OPERATING EXPERIENCE SUMMARY

Office of Environment, Safety and Health OE Summary 2002-16 August 12, 2002 The Office of Environment, Safety and Health (EH), Office of Performance Assessment and Analysis publishes the Operating Experience Summary to promote safety throughout the Department of Energy (DOE) complex by encouraging the exchange of lessons-learned information among DOE facilities.

Operating Experience Summary 2002-16

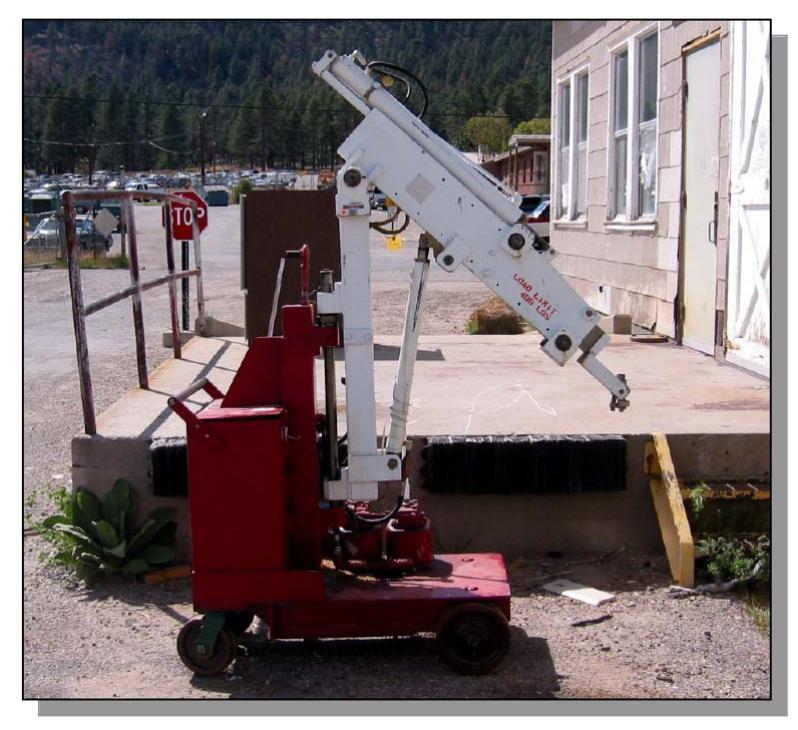
Figure 2-1. Jib crane

n May 15, 2002, at the Los Alamos National Laboratory, a jib crane weighing approximately 900 pounds (Figure 2-1) fell off a lift gate of a box truck and landed on a loading dock, spilling some hydraulic fluid. Workers were lowering the lift gate when the crane shifted and fell. One of the workers received a minor injury that did not require medical attention. (ORPS Report ALO-LA-LANL-HEMACHPRES-2002-0001)

Five workers were loading the jib crane onto a box truck with a lift gate rated for a maximum weight of 1,200 pounds. The crane was to be transported to general excess salvage. In the absence of a procedure for this task, the workers were performing the lift using "skill-of-thecraft," and were unaware that the crane contained lead counterweights. The jib crane did not have a weight label, so the workers estimated the crane to weigh between 800 and 1,000 pounds.

they immediately began to lower the lift gate. As the gate was being lowered, the crane shifted toward a worker who was steadying the crane while standing in front of the lift gate. The worker jumped to the side and hit the sacrum area of his back on a handrail next to the staging area as the crane fell onto the dock where the worker had been standing. The other four workers were standing clear of the area at the time of the incident.

The direct and root causes of this event were identified as personnel error because the workers did not follow the site's property disposal procedure. This procedure stipulates that if a

These occurrences illustrate the importance of analyzing the hazards and developing and implementing hazard controls before beginning work. The workers should have used a forklift to load the crane onto a vehicle large enough to hold the crane. Before this lift began, the workers should have determined if the crane would fit in the box of the truck and

removed the lead counterweights from the crane.

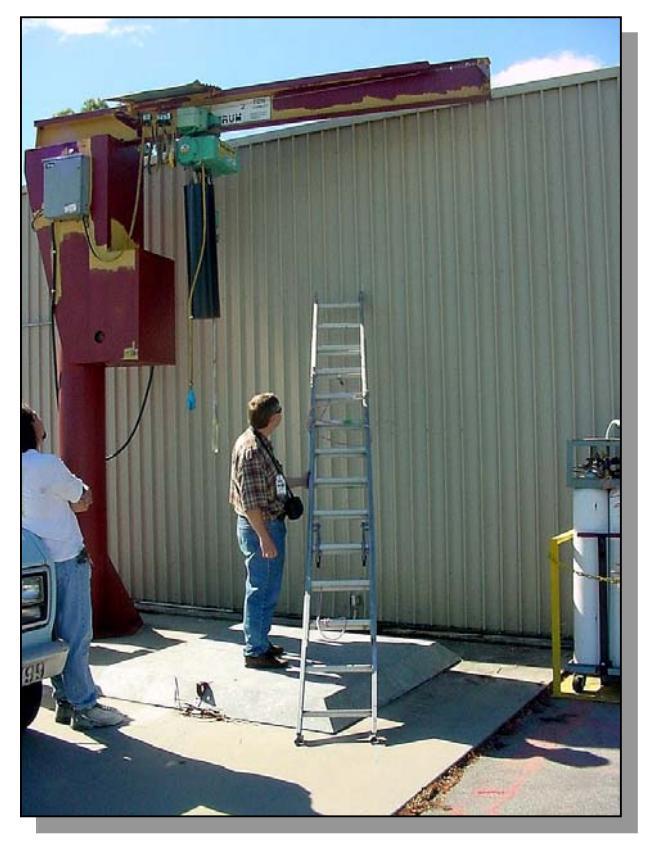
Figure 5-1. The accident scene

n June 18, 2002, at the Stanford Linear Accelerator Center (SLAC), a subcontractor worker was preparing to paint a jib crane when he fell from a 16-foot extension ladder (Figure 5-1) and suffered a compound fracture of his left elbow and hematoma of his right knee. (ORPS Report OAK--SU-SLAC-2002-0004; final report filed July 12, 2002)

The worker placed the top rails of the extension ladder onto the midsection of the crane's boom. The boom was in a full electric stop position next to the wall. As he climbed the ladder, the force of his weight caused the boom to rotate toward the wall. The rails of the ladder slid off the boom, and the ladder fell towards the ground, striking the wall. The worker slid down the ladder approximately 4 feet and fell 6½ feet to the ground.

Results of the subsequent investigation revealed that ladder safety training had not been provided to the worker that was injured.

29 CFR 1910, Subpart D, *Walking-Working Surfaces*, requires that a portable ladder "shall be so placed as to prevent slipping, or it shall be lashed, or held in position." In this case, the site believes the ladder should have been extended so as to have a three-rung clearance over the top of the beam.

The site engineering and maintenance department conducted a general safety meeting to discuss ladder safety. In addition, the purchasing department is in the process of evaluating the existence of safety training programs for "jobshopper" subcontractor organizations.

This occurrence illustrates that workers should receive ladder safety training appropriate to the type of ladder they will be using. In addition, ladders need to be properly extended and secured before workers attempt to ascend them.

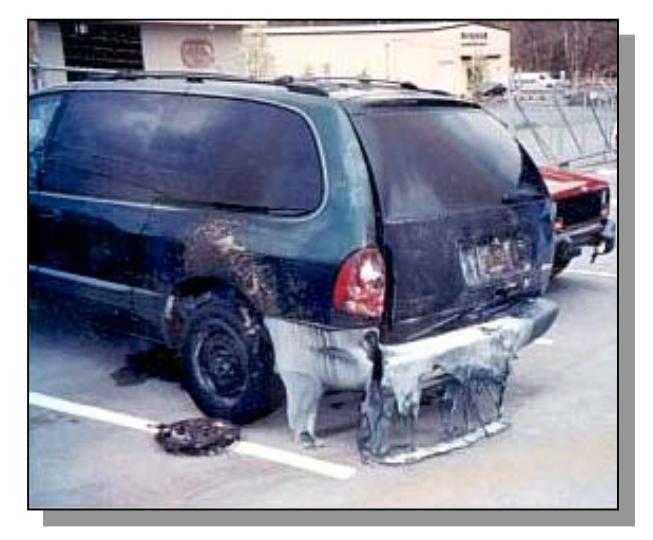
Figure 1. Vehicle burned by refueling fire

Out of an estimated 16 to 18 billion fuelings a year in the United States, most are safe nonevents that pose no danger to consumers. Most of the reported fires have been flash fires with little damage and minimal injuries, and most have occurred at pumps that have no vapor recovery. Motorists need to be aware of the potential that re-entering their car will create static electricity that can cause a fire. Figure 1 shows a vehicle damaged in a

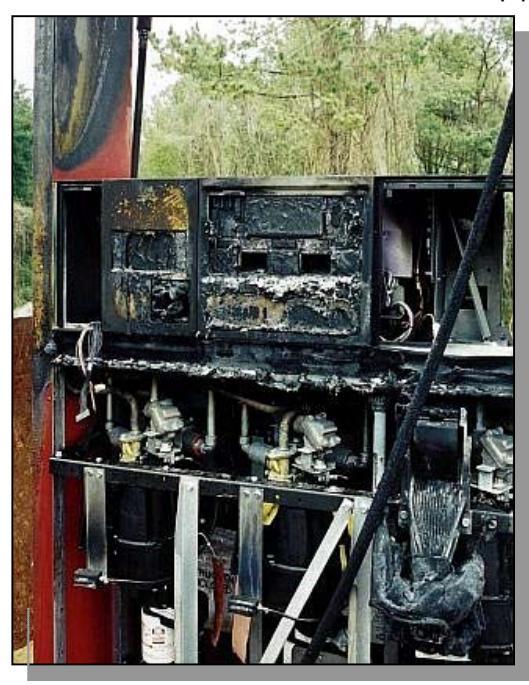
Figure 2. Burned gasoline pump

refueling fire, and Figure 2 shows a burned gasoline pump.
