OPERATING EXPERIENCE SUMMARY

U.S. Department of Energy Office of Environment, Safety and Health OE Summary 2002-18 September 9, 2002 The Office of Environment, Safety and Health (EH), Office of Performance Assessment and Analysis publishes the Operating Experience Summary to promote safety throughout the Department of Energy (DOE) complex by encouraging the exchange of lessons-learned information among DOE facilities.

Operating Experience Summary 2002-18

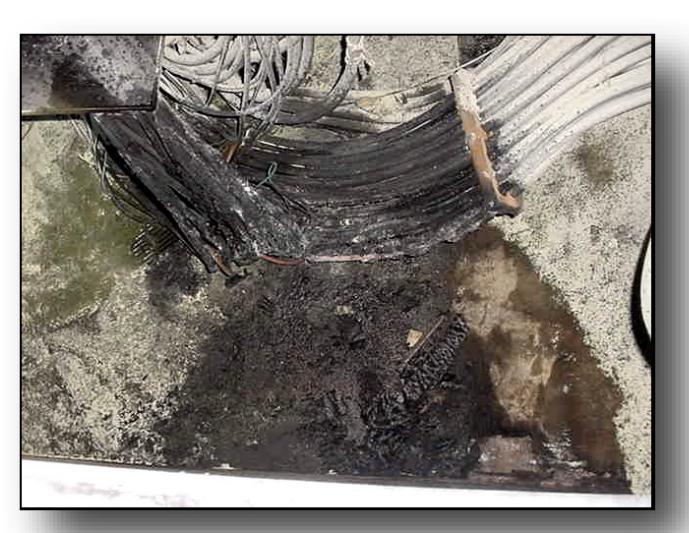
n May 17, 2002, at the Lawrence Berkeley Laboratory, sparks from torchcutting operations fell into a 1-inch opening in a steel plate covering a sub-grade trench and started a fire. The fire department responded and extinguished the fire. Although no one was injured, the fire caused more than \$10,000 damage in addition to research reve-

A construction inspector saw sparks and hot metal falling to the steel deck area, then scattering and falling through a hole in the plates cov-

smelled burning wires. More alarms signaled loss of the radiofrequency signal, main magnet field, and electric power. Minutes later, white smoke was observed behind the main control panel, and cyclotron operations were shut down.

After reviewing the hot work permit, the inspector saw black smoke coming from the power supplies and called the laboratory fire department. The welder serving as the fire watch also called the fire department. When the fire department arrived, they discharged a halon and a CO_2 extinguisher into the power supply enclosures, but the fire continued to burn. When the firefighters removed the cable trench plates, they found burning electrical cables (Figure 2-1), dry leaves, and a wooden ladder (Figure 2-2). The firefighters were successful in extinguishing the fire with a dry chemical extinguisher. The direct cause of this event was the welders allowing sparks and hot metal to fall into an area containing combustibles. The root cause was the welders' failure to follow the precautions listed in the hot work permit, such as using fire blankets to cover floor openings, protect combustibles, or contain sparks, although they had checked these on the hot work permit.

Figure 2-1. Burned cables

Corrective actions include inspecting the trench areas and removing any combustibles, discussing procedures for fire prevention (the use of fire blankets, protecting openings in walls and

> floors, and protecting combustibles), and conducting mandatory training for welders on complying with all requirements of a hot work permit.

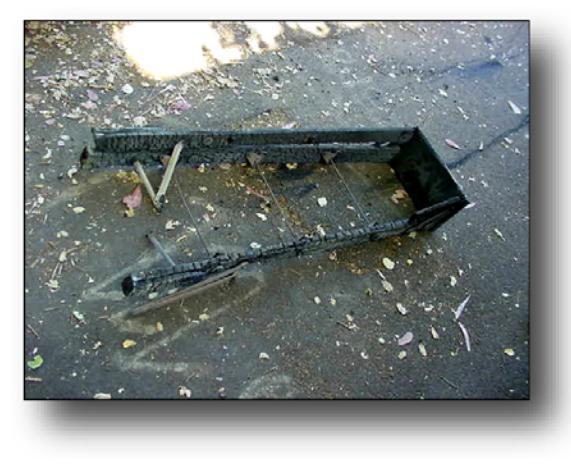
Figure 2-2. The charred ladder

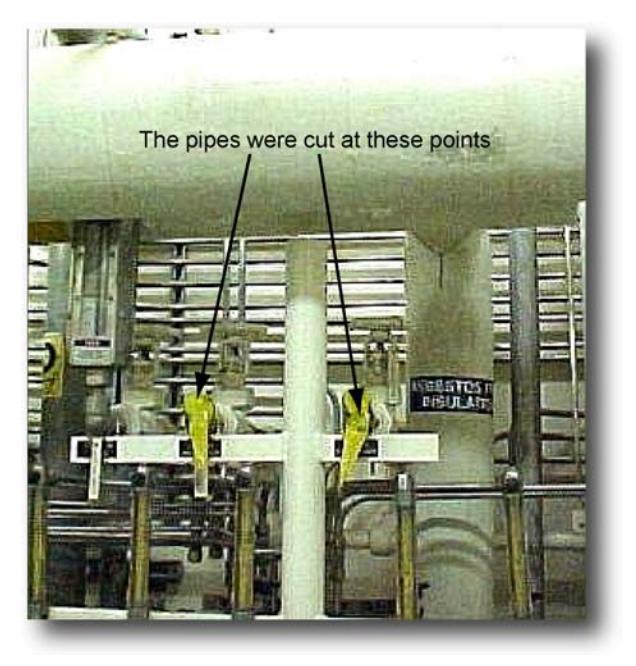
The pipefitters were removing two sections of piping and valves as part of a modification to install remotely controlled valves in the process equipment waste system. When they made the first cut, low-pressure air started leaking from the breached line. Instead of stopping work, a pipefitter closed an upstream valve to isolate the air leak. Before cutting the adjacent air line having an identical configuration, the pipefitter shut a second isolation valve and continued demolition work. Figure 4-1 shows the two upstream isolation valves where the cuts were made (yellow plastic) and from which the resultant air leaks occurred.

Figure 4-1. Isolation valves where cuts were made

- Piping drawings used to establish the isolation boundaries were accurate but difficult to read, contributing to the selection of the wrong isolation valves.

- Lockout/tagout preparers relied solely on drawings and did not walk down the system.
- A pipefitter foreman walked down the lockout/tagout, but overlooked the fact that the demolition boundaries were outside the isolation boundaries.

- The demolition boundaries were not marked or tagged on the piping system.
- The zero-energy check for the presence of elevated pressure was poorly chosen. It required checking a flow indicator that was isolated by downstream valves. Flow indicated zero even though piping was pressurized.

- Project drawings instructed the crew to disconnect the pipe at unions (not with a bandsaw), but, because the unions were not shown in dark lines (designated for demolition), the crew didn't believe they were authorized to disassemble the unions.
