OPERATING EXPERIENCE SUMMARY

U.S. Department of Energy Office of Environment, Safety and Health OE Summary 2002-19 September 23, 2002 The Office of Environment, Safety and Health (EH), Office of Performance Assessment and Analysis publishes the Operating Experience Summary to promote safety throughout the Department of Energy (DOE) complex by encouraging the exchange of lessons-learned information among DOE facilities.

Operating Experience Summary 2002-19

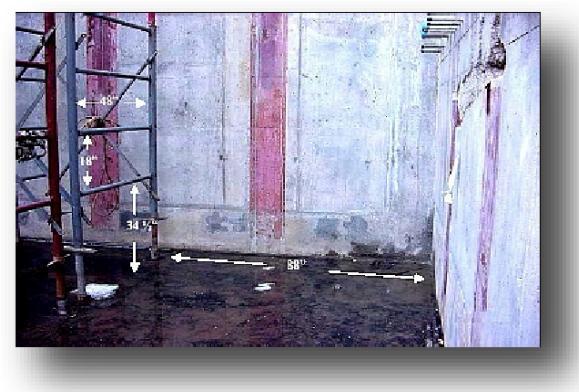
Figure 1-1. The accident scene marked with dimensions

The carpenter who was injured had begun to climb the end frame of a tower assembly and had stepped up to the second rung of the shoring, approximately 52 inches from the floor, when he apparently lost his grip, fell backwards off the shoring and struck his head on the concrete wall behind him. His head struck the wall 1 to 2 feet from the floor. One of the team members called for assistance, and the other stayed with the injured worker.

The Board concluded that the shoring assembly had been constructed in a sufficiently stable manner to support safe climbing. They also determined that the carpenters all had the experience and knowledge necessary to perform this task. The Board concluded that the accident occurred simply because the carpenter lost his grip on the rung.
