OPERATING EXPERIENCE SUMMARY

U.S. Department of Energy Office of Environment, Safety and Health OE Summary 2002-22 November 4, 2002 The Office of Environment, Safety and Health (EH), Office of Performance Assessment and Analysis publishes the Operating Experience Summary to promote safety throughout the Department of Energy (DOE) complex by encouraging the exchange of lessons-learned information among DOE facilities.

Operating Experience Summary 2002-22

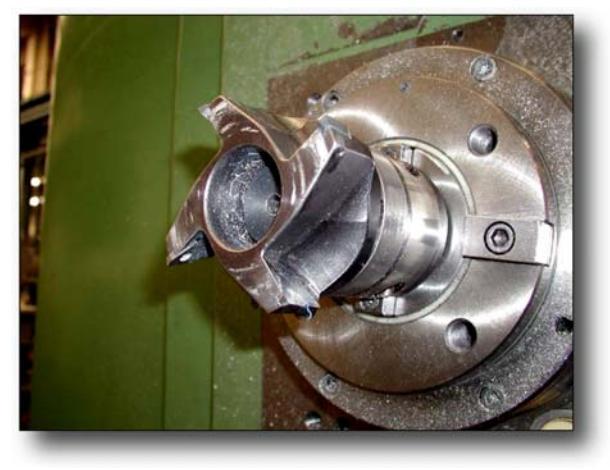
Figure 2-1. Carbide cutting bit

The machinist was setting up an aluminum part on the horizontal boring mill. The mill was fitted with a four-bladed, carbide cutting bit (Figure 2-1) and was rotating at 2,000 rpm. When he completed the setup, the machinist pivoted to his left to exit the machine tool working area, and the carbide cutting bit cut the back of his left shoulder. The machinist felt a brief pull on his shirt and thought that only his shirt was cut. After realizing that a laceration had occurred he applied pressure to his shoulder with a towel and waited for help.

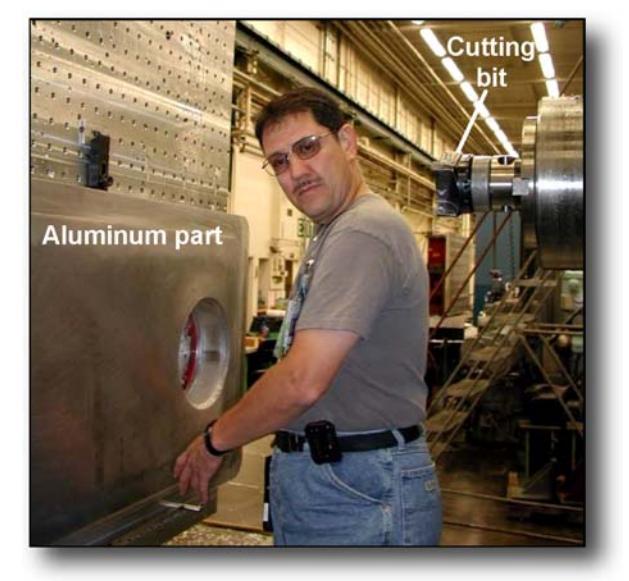
Figure 2-2. Position of machinist and cutting bit

The machinist was fortunate that his clothing did not get caught up in the rotating bit or that his head did not contact the bit, as he could have been badly injured. Figure 2-2 is a reenactment showing a machinist facing the aluminum part with the cutting bit near his shoulder.

The contractor investigated the incident and determined that personnel error was both the direct and root cause of this occurrence because the machinist did not follow established procedures requiring the spindle to be stopped before adjusting machine setup. The contractor also identified the following contributing causes.

1. Personnel error (did not pay attention to detail) – The machinist had worked overtime for a long duration, which could have resulted in a level of fatigue that impacted his alertness and judgment.

Corrective actions included (1) performing a feasibility study on installing engineering controls to prohibit access to the machine-work zone during operation and (2) posting warning signs (consistent with industry standards) on machine tools in the complex. In addition, a review of the Machine Tool Operation Safety Training Program was performed to verify that all machine tools were identified and properly referenced in safety documentation.

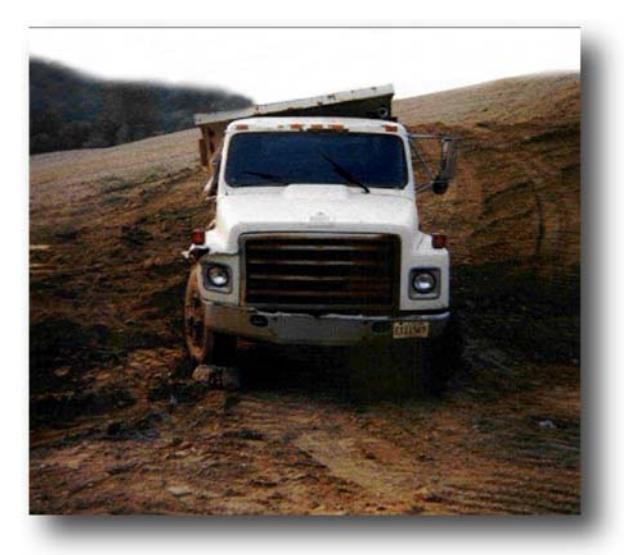
Figure 3-1. Damaged truck, front view

In two separate accidents in August 2002, contractor-operated dump trucks overturned during construction activities. On August 14, at the Lawrence Berkeley National Laboratory (LBNL), a dump truck overturned while dumping a load of construction material. On August 22, at the Oak Ridge Y-12 Site, a dump truck overturned while dumping a load of topsoil at a landfill. No serious injuries resulted from either accident. (ORPS Reports OAK--LBL-OPERATIONS-2002-0004 and ORO--BJC-Y12WASTE-2002-0006)

In the LBNL occurrence, the truck driver suffered only minor bruises. Approximately 2 gallons of diesel fuel and a small amount of antifreeze spilled onto the ground.

Investigators identified inattention to detail as the direct cause of the LBNL incident. The driver failed to ensure that the truck was in a stable configuration before raising the bed to dump the load. A contributing cause was inadequate supervision. A supervisor was not present at the time of the incident, and there was no spotter to help the driver as he positioned the truck to dump the load. A root cause analysis identified a deficiency in work organization and planning. The hazards analysis fo-

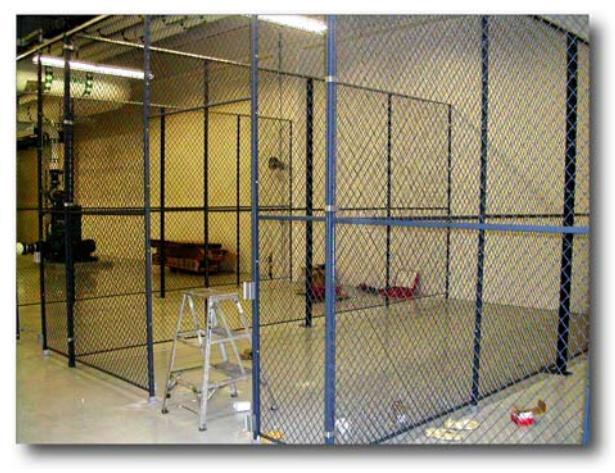
Figure 4-1. A chain-link cage assembly

Three workers were installing chain-link metal storage cages like the one shown in Figure 4-1. Installing the cages required placing a chainlink panel upright, sliding floor shoes under the frame ends, and securing the C-shaped metal

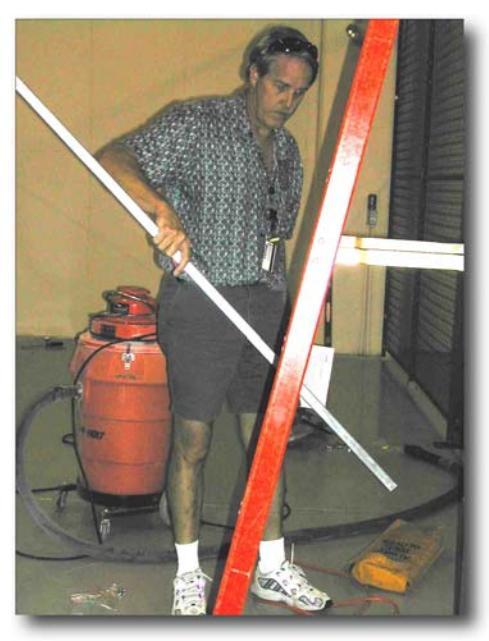
Figure 4-2. The top cap piece

top cap (Figure 4-2), which measured 6 feet long by $1\frac{1}{2}$ inches wide by 1/16 inch thick, across the panel joints, with $1\frac{1}{2}$ -inch threaded bolts and nuts.

that a floor shoe was missing. He climbed down the ladder, and he and a co-worker lifted the panels while the third worker slid the floor shoe onto the frame from beneath. One of the workers then returned to assembling panels while the other two used a ball-peen hammer to align the floor shoe with mounting holes. Because the top cap had not yet been secured, the hammering jarred it loose and it fell. The cap struck the right hand of one of the workers, causing the fracture to her metacarpal bones.

Investigators determined that the root cause of this event was failure to recognize a hazard. The worker who was securing the top cap failed to recognize the hazard posed by the unsecured

cap when he was distracted by the missing floor shoe.

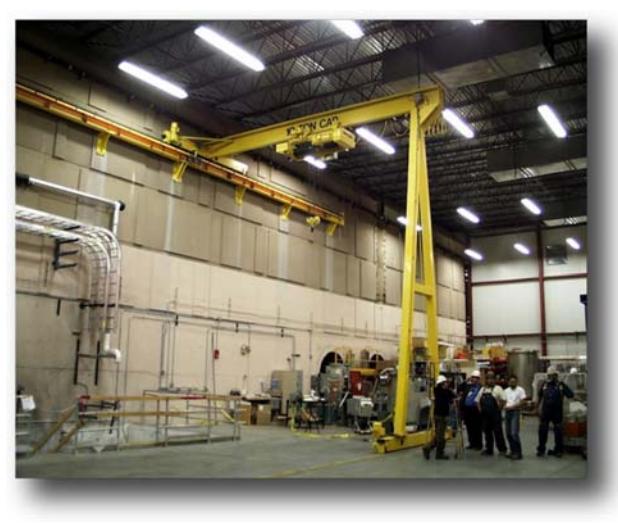
Figure 5-1. The gantry crane

Inspectors could not determine when or how the crane sustained physical damage to its structure. However, they noticed black scuffmarks on both ends of the bridge end trucks, and be-

lieved that a forklift or other piece of heavy equipment caused the damage. A qualified crane operator performed the monthly inspection on September 10, 2001, and reported that the crane was in good working order with no structural abnormalities. On October 5, 2001, certified crane inspectors performed an annual crane inspection. This inspection found that the gantry crane had several mechanical and structural defects. The investigators concluded that the damage to the crane occurred sometime between September 10 and October 5, 2001, and was never reported. The investigators also found evidence that unauthorized repairs had been attempted on the crane. The crane was placed out of service and required extensive repairs costing approximately \$16,000. Informal and inadequate controls on the use of heavy equipment contributed to this problem.
