# OPERATING EXPERIENCE SUMMARY

U.S. Department of Energy Office of Environment, Safety and Health OE Summary 2002-24 December 4, 2002 The Office of Environment, Safety and Health (EH), Office of Performance Assessment and Analysis publishes the Operating Experience Summary to promote safety throughout the Department of Energy (DOE) complex by encouraging the exchange of lessons-learned information among DOE facilities.

# **Operating Experience Summary 2002-24**

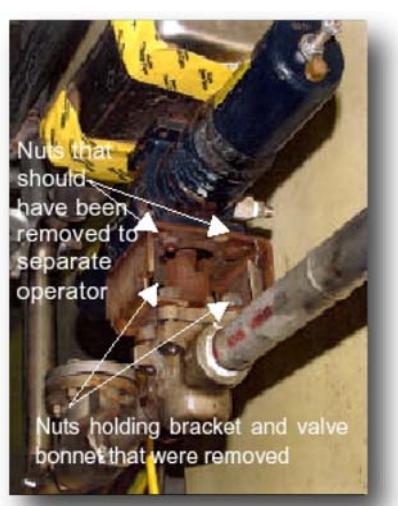
Figure 1-1. The air-operated valve configuration

tional fasteners holding the valve bonnet. Figure 1-1 illustrates the valve and bracket with the fasteners, and Figure 1-2 shows the valve assembly with the actuator removed. He removed four fasteners holding the bracket and

valve body, anticipating that other fasteners secured the valve. Instead, the fasteners held the valve bonnet to the valve body as well, allowing nitric acid to leak from the bonnetto-body joint. The operator quickly secured the valve, and he and the other four workers in the room evacuated. Plant firefighters responded to the scene, and the ventilation system was aligned to exhaust the fumes from the building. The spilled acid was cleaned up the same day and industrial hygiene personnel verified the atmosphere free of acid fumes.

The direct cause of this event was the operator's error in assuming that this valve assembly was configured like those he had disassembled previously. The root cause was inadequate work planning. No one had recognized the potential

Facility management took a number of corrective actions. The engineering group evaluated a method for removing air-operated valve actuators without breaching the system. Walkdown training was given to foremen, operations, engineering and maintenance personnel, and job

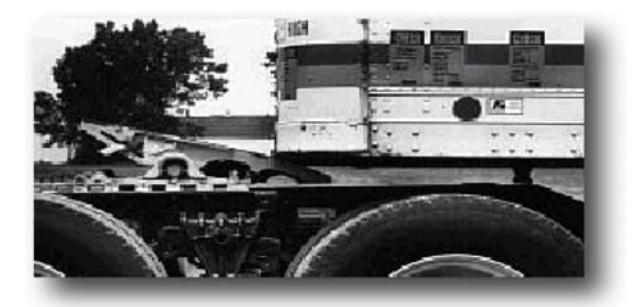
Figure 2-1. Uncoupled tractor and trailer

Figure 2-1 shows the fifth wheel of a tractor in position to couple with a trailer.

- Lubricant was not properly applied to the fifth-wheel mechanism.
- There was no procedure for inspecting the fifth wheel.
- Drivers failed to verify proper coupling.
- Manufacturers' recommendations for cold weather service were not followed.
- The latching tongue on the fifth wheel cracked while towing a trailer.
- The height between trailer and tractor was such that a high-hitch condition resulted.
- The safety latch pin was either not installed or vibrated out.

- Perform maintenance on all fifth wheels that stick, hang-up, or do not operate freely.
- Clean and degrease fifth-wheel mechanisms and apply new grease before cold weather.
- Use 90-weight oil in freezing temperatures for latching mechanisms rather than using grease.
- Ensure latching mechanisms operate freely.
- Perform a test tug on the trailer.
- Check the alignment of the tractor to the trailer as well as the surface of the ground. If the trailer is slightly higher or at an angle, the latching mechanism may not completely latch, which may not be revealed during a test tug.
- Ensure the fifth wheel makes contact with the trailer and raises it during latching.

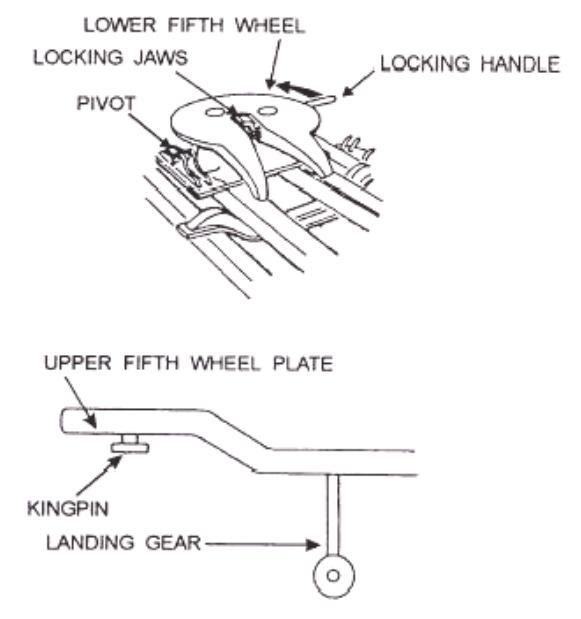
Figure 2-2. Fifth-wheel arrangement

A tractor and trailer are separate units joined together by a fifth wheel (Figure 2-2). The fifth wheel consists of two metal plates: one on the

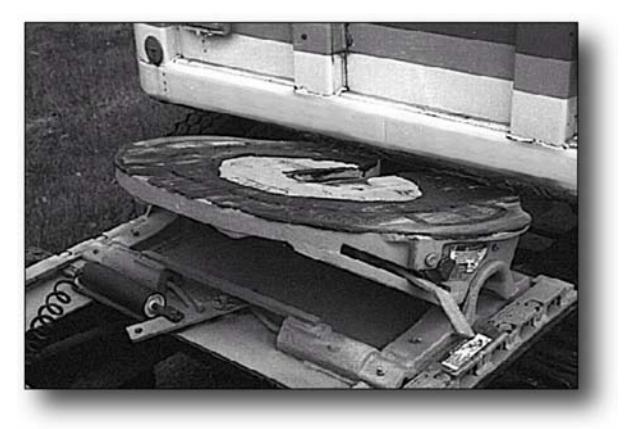
Figure 2-3. Lower fifth-wheel plate

tractor (lower fifth wheel) and one on the trailer (upper fifth wheel). The upper and lower fifth wheels form a flexible coupling that permits both rotational and vertical movement between the tractor and trailer. The upper fifth wheel consists of a flat plate and a kingpin. The lower fifth wheel has locking jaws that lock around the kingpin to couple the tractor-trailer together. Figure 2-3 shows a well-greased lower fifth-wheel plate.

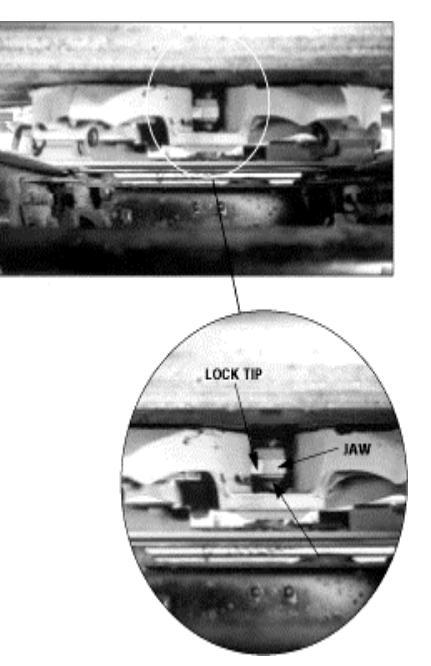
Figure 2-4. No gap between upper and lower plates

Commercial driver's manuals typically provide guidance and instructions for tractor trailer coupling and uncoupling, including coupling inspections and general vehicle walkaround inspections. These inspections should include a check to ensure that the trailer bed plate is resting on the top surface of the fifth-wheel plate with no visible gap or indication of high hitching (Figure 2-4).

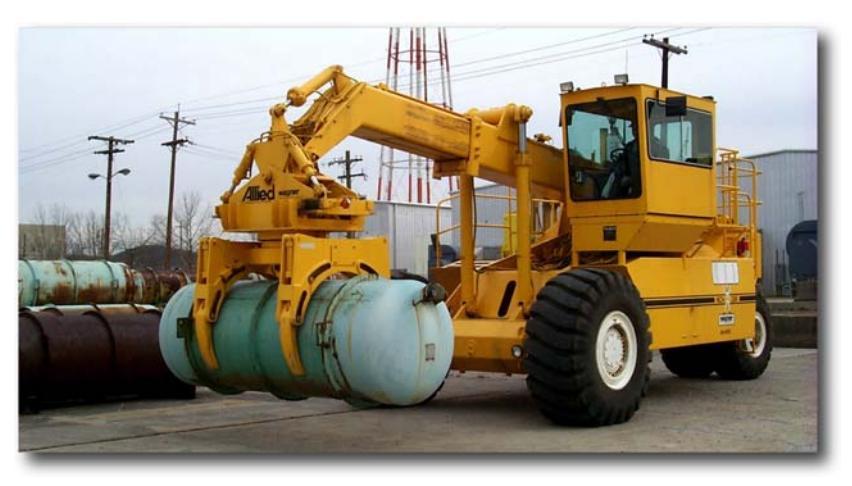
Figure 3-1. Allied-Wagner cylinder handler

The Model NCH-35, Allied-Wagner cylinder handler (Figure 3-1) is classified as a safetysignificant component in the safety basis for the UF<sub>6</sub> cylinder storage yards at ETTP. The handler was being used to transport a 10-ton depleted UF<sub>6</sub> cylinder (Model 48, Serial #9209, gross weight 24,010 pounds at 0.2 percent assay). As the handler moved forward, the tines on one end of the cylinder opened unexpectedly, and the cylinder dropped. Workers lowered the supported end of the cylinder to the concrete, placed the cylinder in a secure position, and inspected it for damage. They moved the cylinder handler to the ETTP garage for additional inspections and tests.

Facility personnel critiqued the event, and partially reconstructed it using a concrete-filled cylinder. During event reconstruction, an interlock design feature failed in two of four trials, with the concrete cylinder dropping only when the operator intentionally actuated the lever to open the tines. An Allied-Wagner factory representative stated that, because of the interlock design feature, the arms should never release under

Investigators identified the direct cause of this occurrence as personnel error (inattention to detail). Tests indicated that the only way a cylinder could be dropped was if the operator actuated the lever to open the tines. The root cause of the event was identified as a design problem. There was no designed fail-safe feature to preclude an operator from accidentally actuating the open lever while carrying a cylinder. An equipment/material problem was a possible contributing cause. The hydraulic cylinder packing may have reached its end of life and allowed the hydraulic pressure in the actuating mechanisms for the tines to decay.

- Install a proximity sensor to signal the presence of a cylinder in the tines and disable the operator's open/close actuating lever for the tines.
- Install a set of pilot-operated check valves designed to maintain the hydraulic pressure level in the tine-closing line when the open/close actuating lever is in the neutral position.
- Inspect and rebuild the hydraulic cylinder piston packing on the handling units as necessary to reduce the probability of hydraulic pressure decay in the tine closing lines.
