OPERATING EXPERIENCE SUMMARY

U.S. Department of Energy Office of Environment, Safety and Health OE Summary 2002-25 December 16, 2002 The Office of Environment, Safety and Health (EH), Office of Performance Assessment and Analysis publishes the Operating Experience Summary to promote safety throughout the Department of Energy (DOE) complex by encouraging the exchange of lessons-learned information among DOE facilities.

Operating Experience Summary 2002-25

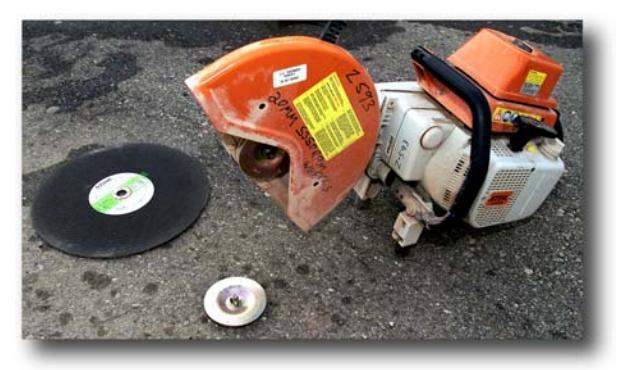
At Fernald, a laborer supervisor had demonstrated how to change the abrasive wheel on a Stihl Model TS-760 CutquickTM cutoff machine (saw) just before the incident occurred. The wheel is held in place by a bolt through a double-tabbed thrust washer that is tightened against the wheel using a wrench. According to the supervisor, the wheel was properly installed and torqued onto the spindle. The cutoff saw (Figure 1-1) has a 6.42-horsepower engine with a maximum spindle speed of 5,350 rpm, and the 14-inch-diameter abrasive wheel is rated for a maximum speed of 5,460 rpm.

Figure 1-1. Gas-powered cutoff saw and abrasive wheel

Investigators believe the spindle bolt backed out of the spindle threads because the engine was revved repeatedly during startup. A manufacturer's representative said that rapid deceleration could apply left-hand rotational torque to the spindle bolt, causing it to spin out of the spindle during startup if the saw blade was decelerated rapidly (e.g., revving the engine repeatedly or a rough-running engine). Witnesses heard the engine being accelerated and decelerated repeatedly before the incident occurred. In addition, the saw had not been operated for more than a year and could have been running roughly.

As a corrective action, the contractor will revise training for this saw to include specific steps that ensure (1) the abrasive wheel is properly torqued, (2) the engine is correctly warmed up, and (3) the spindle bolt is verified tight after initial startup of the saw following wheel replacement.

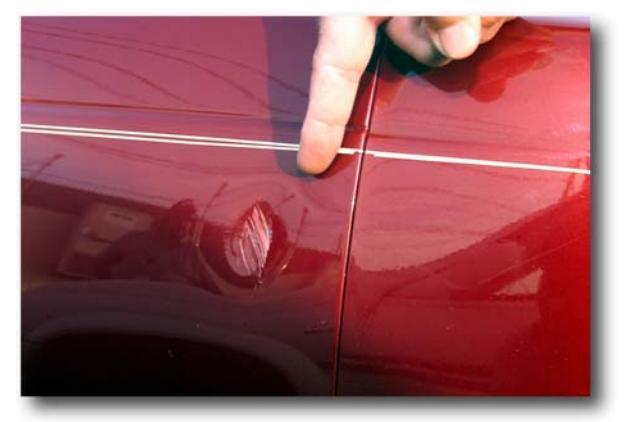
After the wheel was installed and the guard was in place, a laborer took the saw outside, set it down on the pavement, and started the engine to allow it to warm up. At that same time, a project manager pulled into a parking space approximately 40 feet from where the saw was sitting and got out of his car. He could hear the saw running loudly nearby at high speed. After getting something from the trunk, he heard the laborer yell. The manager looked up and saw the blade in the air, coming down directly toward him. He lunged forward several steps, while the blade bounced off the hood of a car next to him, traveled another 6 feet through the air, hit the driver's side of his car (Figure 1-2) where he had been, then fell to the ground and spun out its remaining momentum.

Figure 1-2. Impact damage to manager's car

The laborer stated that the thrust washer had fallen off and the abrasive wheel spun forward on the pavement about 15 feet, then went airborne and traveled about 25 feet before it hit the two cars.

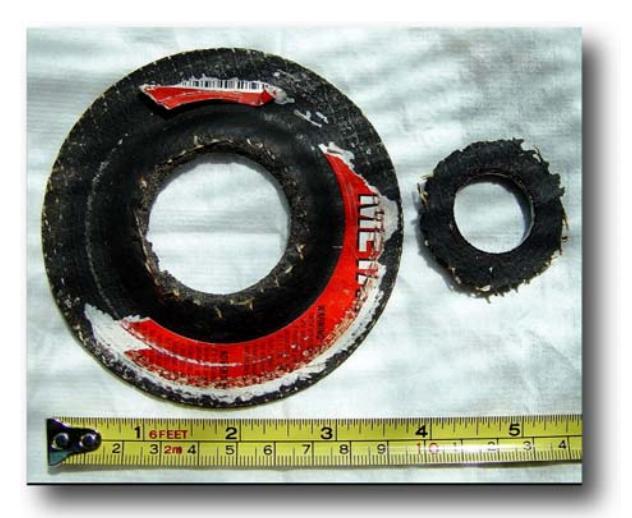
At the Oak Ridge National Laboratory, an employee was using a 4-inch side grinder with an abrasive cutoff wheel when the outer rim of the cutoff wheel suddenly separated from the center, allowing the outer rim to fly off the grinder and across the room. The grinder had a safety guard for employee protection. No one was hit, as the employee was the only one in the room at the time. When he reported this incident to the project leader, he also mentioned that a similar event had occurred that week when another employee experienced the same type of failure.

The pieces of the cutoff wheel (Figures 1-3 and 1-4) were retrieved for inspection. Microscopic analysis of the wheel showed radial cracks, indicating that the wheel had been over-torqued during installation.

Figure 1-3. Separated parts of cutoff wheel

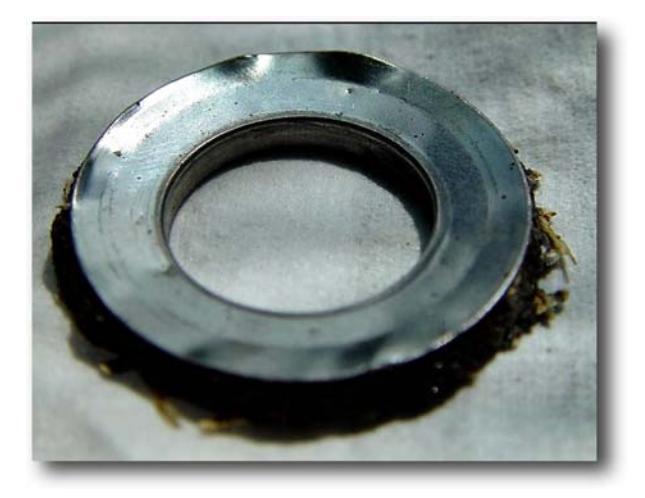
Figure 1-4 Metal center section

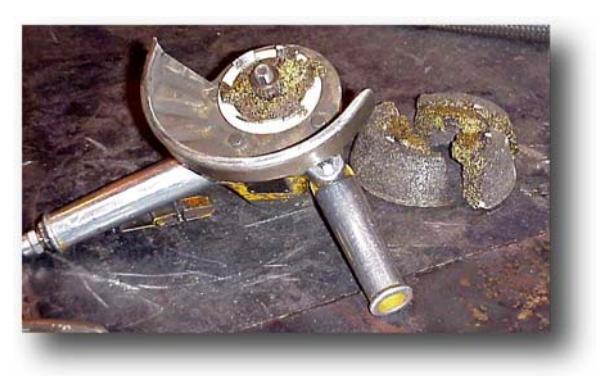
A pipefitter was using a handheld pneumatic grinder when the grinding wheel (6-inchdiameter cup stone) disintegrated (Figure 1-5).

Figure 1-5. Pneumatic grinder and pieces of cup stone

Investigators determined that the pipefitter had performed a pre-use visual inspection of the cup stone and grinder and did not observe any chips, cracks, or other damage. They later determined that the stone was rated to 6,000 rpm, while the grinder was rated for 7,700 rpm.

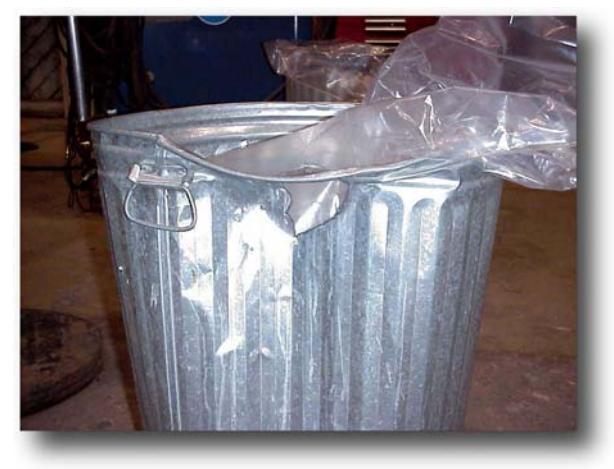
The guard deflected the broken pieces away; however, the largest segment traveled approximately 15 feet and penetrated the side of a

metal trash can (Figure 1-6), knocking the can about 15 feet. Fragments were dispersed over an area of approximately 400 square feet. There were no injuries. (ORPS Report RL--PHMC-FSS-1999-0006)

Figure 1-6. Damaged trash can

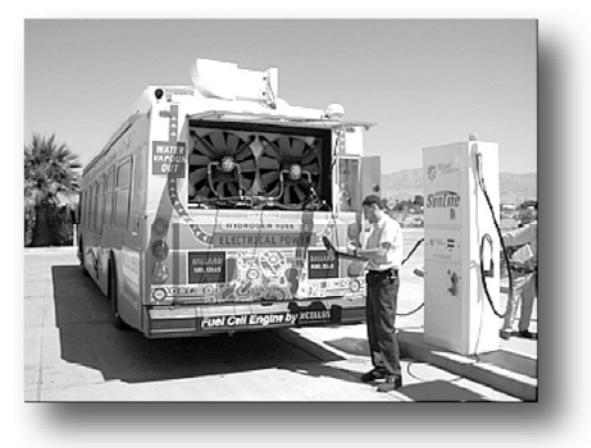
The mechanics were raising the rear of a hydrogen prototype bus, like the one in Figure 3-1, and placing it on jack stands. After chocking the wheels, they used bottle jacks on each side of the rear axle to raise the bus high enough to place a 20-ton hydraulic jack under the differential. With the bus resting on a pair of small jack stands, they raised the bus by the differential so that the weight of the bus was balanced on the hydraulic jack.

Figure 3-1. A hydrogen cell prototype bus

The construction manager ordered a root cause analysis, which revealed a number of causal factors. The most obvious of these was the small jack stand breaking and dropping the bus to the ground on one side. Even more significantly, the work package failed to provide adequate information on the type of bus and environment in which the mechanics would be working, and no procedure existed for jacking up vehicles. Investigators were unable to conclusively determine the reason the hydraulic jack tipped.

Following the critique, the construction manager began developing a procedure on jacking and cribbing mobile equipment. Training will be provided to mechanical personnel when the procedure is complete. In addition, the construction group will develop a system for identifying work requests involving different mobile equipment.

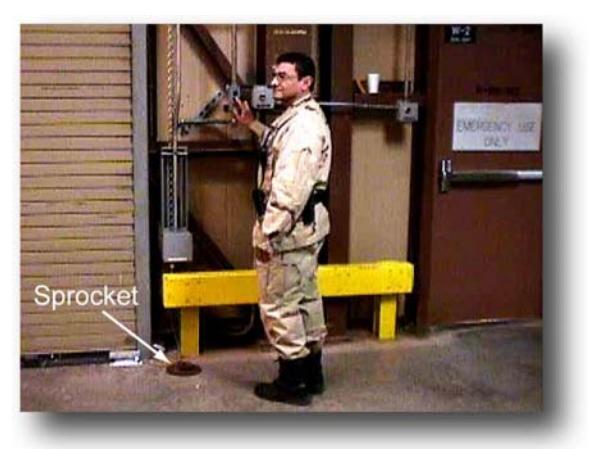
On November 18, 2002, at the Pantex Plant, a 5pound chain sprocket for a roll-up door fell to the floor and landed approximately 1 foot from a security police officer (SPO). The position of the SPO to the sprocket at the time of the incident is shown in Figure 5-1. The SPO was attempting to operate the door at the time of the incident, and was not injured. Maintenance personnel locked and tagged out the roll-up door. (ORPS Report ALO-AO-BWXP-PANTEX-2002-0059)

Figure 5-1. Position of SPO to sprocket on floor

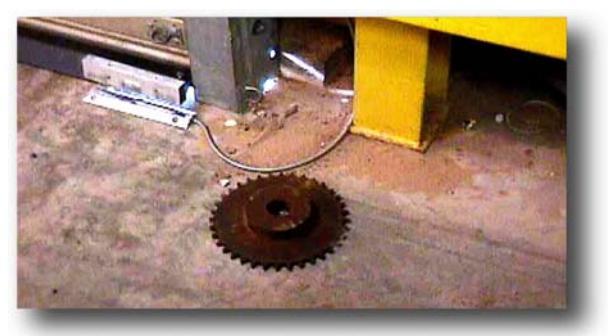
Investigators determined that the 6-inchdiameter sprocket (Figure 5-2) mounted on the door drum came off the shaft. A collar that locks the drum shaft in place slipped, allowing the drum to move and causing the sprocket to become misaligned. The misalignment caused the drive chain to put side pressure on the sprocket, allowing it to walk off the shaft and fall to the floor.

Figure 5-2. Sprocket on floor near the door

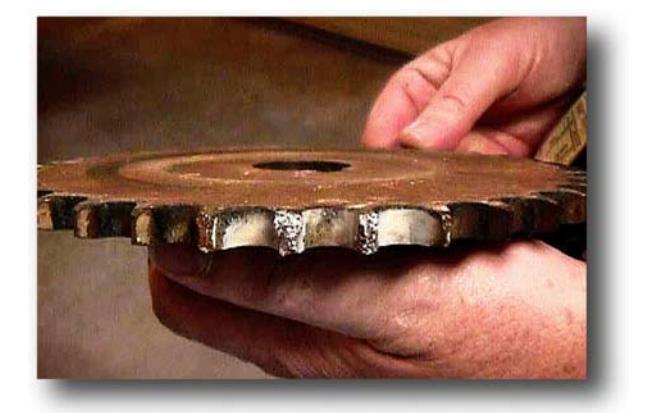
The sprocket hit the floor with enough force to damage some of the teeth (Figure 5-3) and the concrete floor.

Figure 5-3. Sprocket and damaged teeth from impact
