OPERATING EXPERIENCE SUMMARY

U.S. Department of Energy
Office of Environment, Safety and Health
OE Summary 2003-07
April 7, 2003

Operating Experience Summary 2003-07

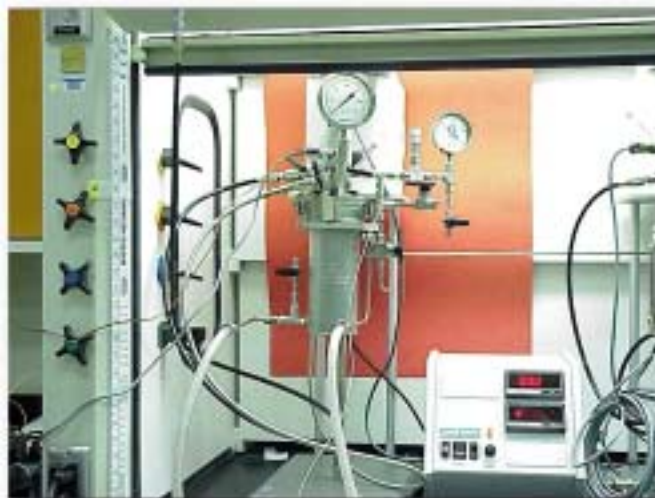
Researchers had been conducting the experiment since June 2001 to develop a storable form of ClO_2 . To make a storable form, the researchers generated ClO_2 by reacting a gaseous mixture of 4 percent chlorine and nitrogen with sodium chlorite in a reactor bed, in accordance with a hazard control plan. The ClO_2 then passed into a Parr® metal reactor vessel at 0°C and 2 psi pressure (a typical setup is shown in Figure 1-1) to form a semi-

Figure 1-1. A typical Parr vessel system

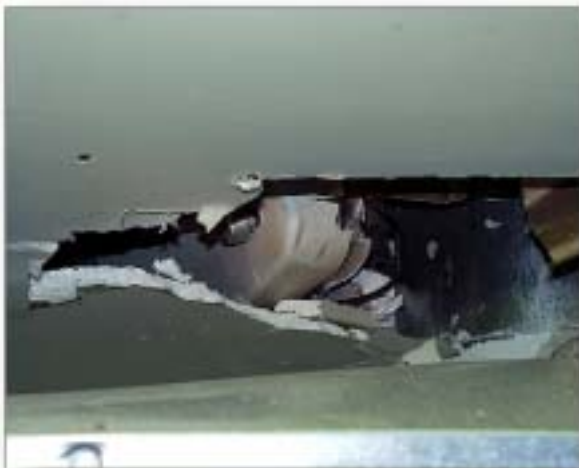
Figure 1-3. The shroud over the Parr vessel protruding from the ceiling

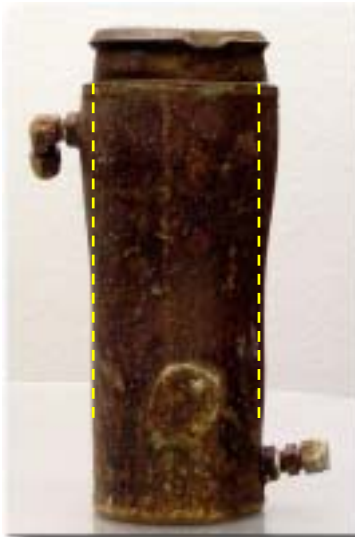
The estimated 68 grams of liquid ClO₂ exploded at about 75,000 psi, equivalent to 30 to 40 grams of TNT. The Parr vessel, with a maximum allowable working pressure of 3,000 psi, was deformed (Figure 1-2), and its propelled lid and locking rings destroyed the fume hood, penetrated the plaster walls and ceiling (Figure 1-3), and knocked out a section of hollow concrete block on the top of the wall. If the researcher had not been monitoring the temperature readout or had not immediately recognized the unsafe condition, the two researchers would most likely have been severely injured.

Figure 1-2. The deformed Parr vessel

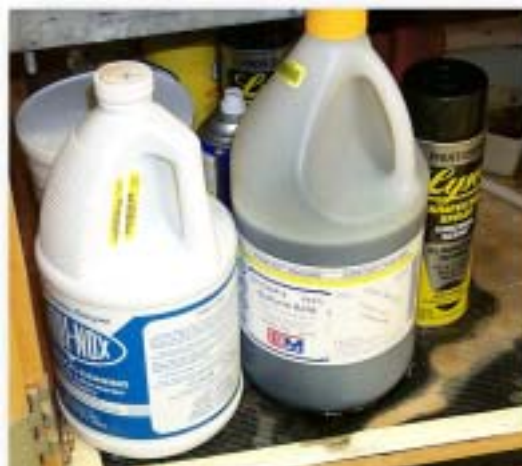
The researcher had blended the potassium dichromate with concentrated sulfuric acid in a 1-gallon plastic product container (Figure 2-1) to make an effective glass cleaner (a standard laboratory practice). The researcher stored the mixture under a laboratory sink without using a secondary containment tray. Several other containers, including aerosol

Figure 2-1. Leaking container of solution (with yellow cap)

- 1. Place liquid chemicals in appropriate containment trays and segregate by compatibility.**
- 2. Check for compatibility before mixing chemicals and use appropriate containers.**
- 3. Use a proper storage locker (e.g., acid cabinet or flammable storage cabinet).**
- 4. Minimize the amount of hazardous materials in the work area. Large containers cost slightly less per unit to purchase, but may represent an unnecessary risk.**

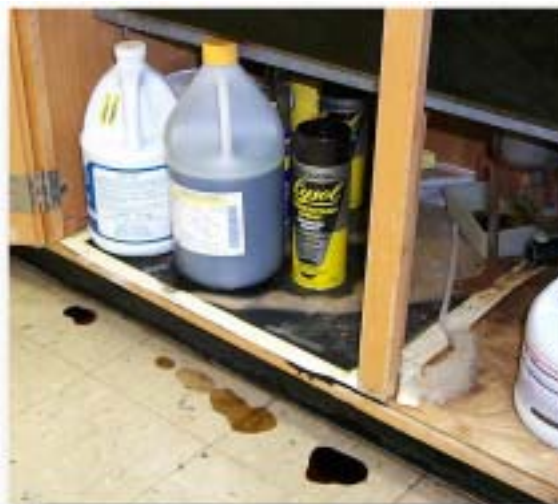
The leaking acid/dichromate solution pooled on the floor of the cabinet and caused charring of the wood from chemical exposure. Over time, the solution worked its way underneath the cabinet door and spilled onto the floor of the room (Figure 2-2).

Figure 2-2. Chemical leak and spillage on floor

Fire department responders, wearing supplied-air respirators and chemical-resistant suits, removed the leaking plastic container and the aerosol containers. They spread neutralizer on the area to contain the spill. The contents had been marked on the container, which greatly aided responders in dealing with the cleanup. The floor of the cabinet was subsequently removed and disposed of as hazardous waste.

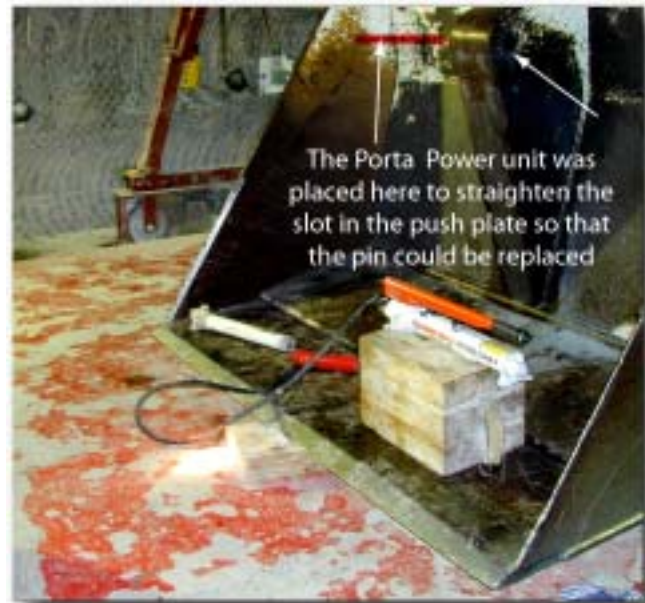
Two maintenance workers had heated the push plate and were applying pressure to it with the Porta Power (Figure 4-1). They needed to add an extension to the end of the

Figure 4-1. The location on the bucket where the Porta Power was used

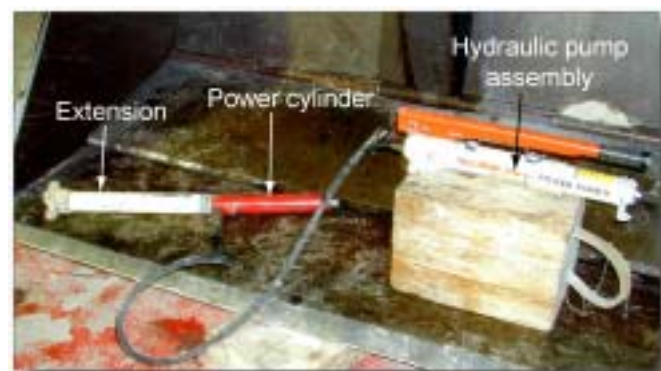
extension piece, they used an older model that was not threaded. Since there were no threads to hold the pieces together, the workers just aligned the power cylinder and extension, and depended on pressure and friction to keep the two pieces in place. When they applied additional pressure with the Porta Power unit, the extension slipped out of position and struck one of the workers causing scrapes and bruises on his upper chest and left shoulder. He appeared to be disoriented and to have bitten his tongue. A full examination, including x-rays, confirmed that the worker had not

Figure 4-2. The portable hydraulic jack and its extension

Facility managers held safety meetings with the involved workers and other personnel who may need to use Porta Power equipment to stress the importance of using the correct extension with the correct unit.

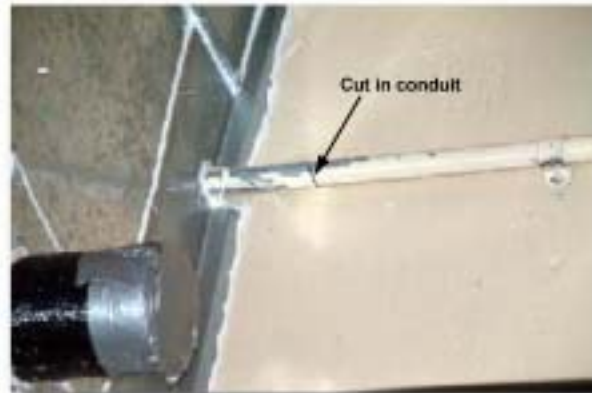
Two workers were cutting through pipes and conduit during demolition of systems in a deactivated building. They were standing on the platform of a scissor-lift equipped with rubber wheels that was about 6 feet above the floor. The worker who cut into the conduit was using an Underwriters' Laboratory-approved, hand-held reciprocating saw that was double-insulated and properly grounded. Both workers were dressed in full anti-contamination clothing, including coveralls, leather gloves over rubber gloves over cotton gloves, and plastic booties. Figure 5-1 shows the partially cut conduit still attached to the ceiling.

Investigators determined that the affected conduit contained an energized control circuit conductor connected to a 110-volt power source on the other side of the wall. They discovered a blown fuse associated with the circuit during their investigation. As shown in Figure 5-2, the affected conduit had an air-gap (physical separation) on one end; however, the drawings used during work planning did not show a tee junction (like the one shown in Figure 5-2) in the conduit run or the energized circuit that used the junction. Work planners could not inspect portions of this conduit because a temporary structure enclosed portions of the conduit run.

Figure 5-1. Partially cut conduit

- All conduit scheduled for removal will

be re-examined and re-marked with color coding.

- Workers will be re-trained on the hazards of cutting into energized conduit and on the significance of color-coded conduit.
- Conduit to be removed will have air gaps verified at both ends of the conduit.

- A method for isolation of all utilities in a building will be prepared and approved before demolition activities are resumed.

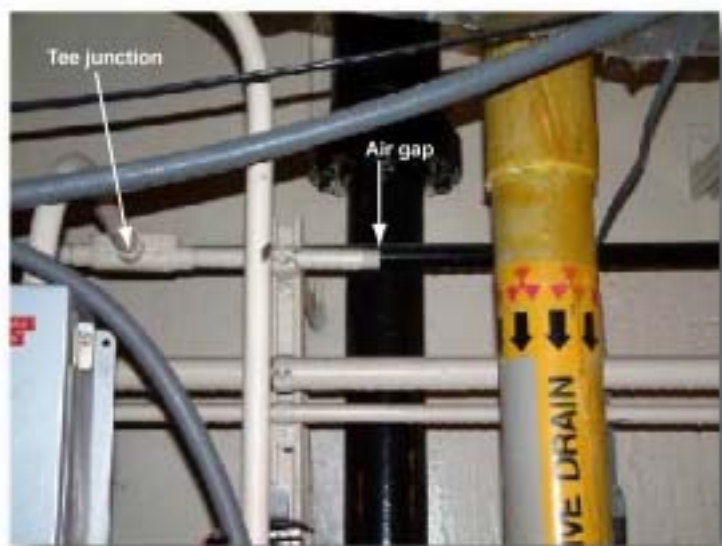
Figure 5-2. Air gap in conduit and tee junction
