# Operating Experience Summary

U.S. Department of Energy Office of Health, Safety and Security OE Summary 2008-03 April 10, 2008

### Look Out Below — The Hazards of Falling Objects

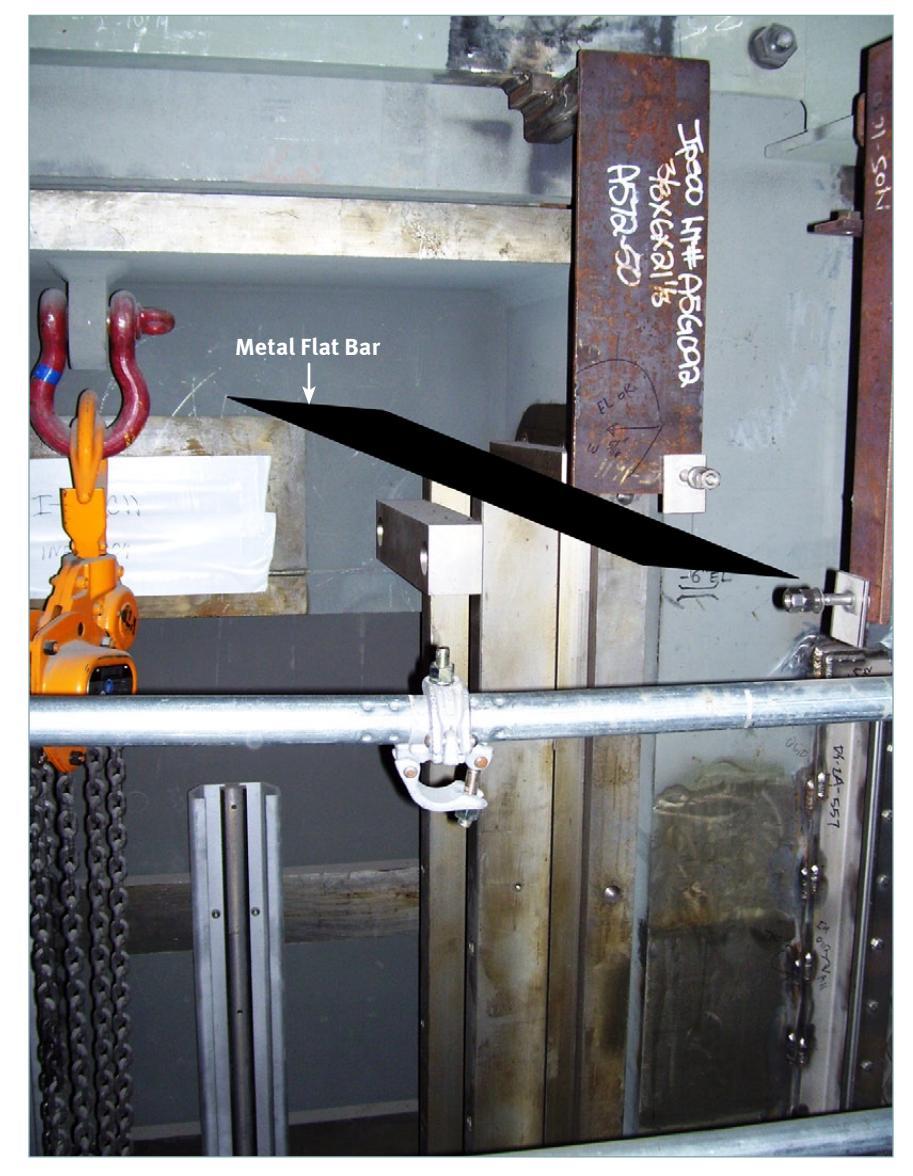
Workers had attached the flat bar to a stainless steel member of an elevator using magnets. (Figure 1-1 shows the scaffolding and the placement of the flat bar.) The laser sight also has a magnetic base, which is used to connect the instrument to the metal bar and hold it in place. When the crew member reached down and put the laser sight on the flat bar, the magnets holding the bar to the stainless steel member detached, and the bar fell. The worker was able to grasp the laser sight instrument and keep it from falling along with the bar. Figure 1-2 shows where the bar landed underneath the scaffolding and the location of the carpenter at the time of the incident.

Investigators determined that the surveyors failed to ensure that the flat bar was attached securely. However, they also determined that the work package documentation for both work groups was inadequate and did not provide for thorough job scoping and planning for any associated hazards. As a result of the work package deficiencies, signs for overhead work had not been posted before work began and no barrier tape or other restrictive measures were in place.

Figure 1-1. Illustration of metal piece placed on scaffolding

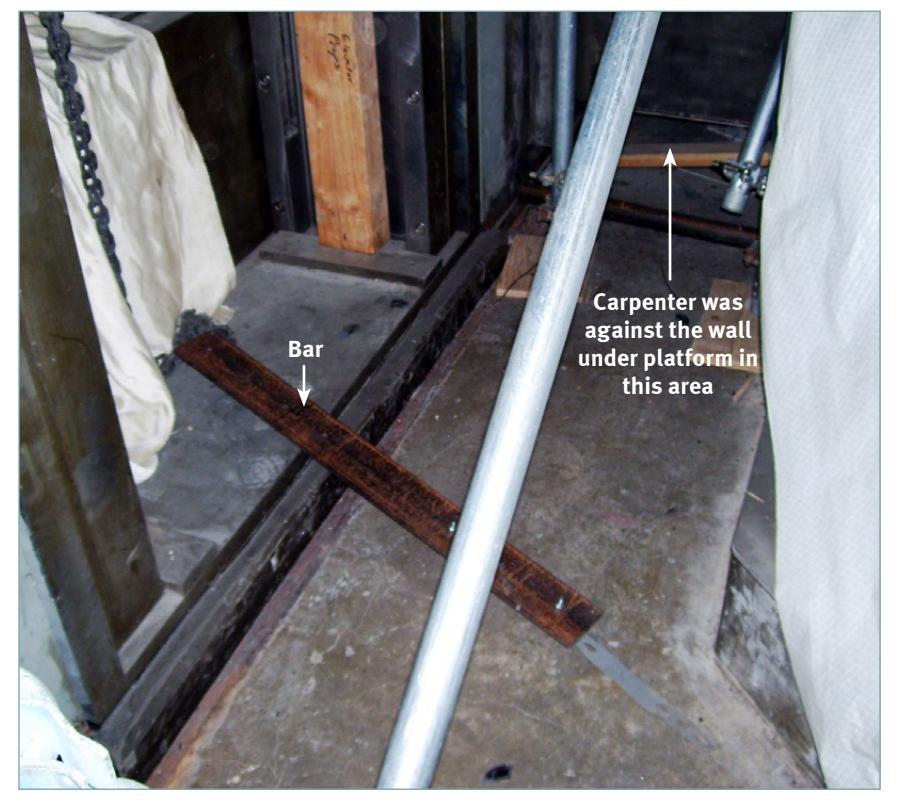
On November 7, 2007, at Hanford, a worker on a subcontractor survey crew dropped a metal flat bar for a laser sight instrument from a scaffolding platform. The bar, which weighed about 7 pounds, fell 17 feet and landed near a carpenter working directly below the survey crew. The carpenter was standing within 2 or 3 feet of where the bar landed and could have been seriously injured had it hit him. (ORPS Report EM-RP--BNRP-RPPWTP-2007-0020; final report issued December 19, 2007)

Figure 1-2. Location of bar after falling and area where carpenter was standing

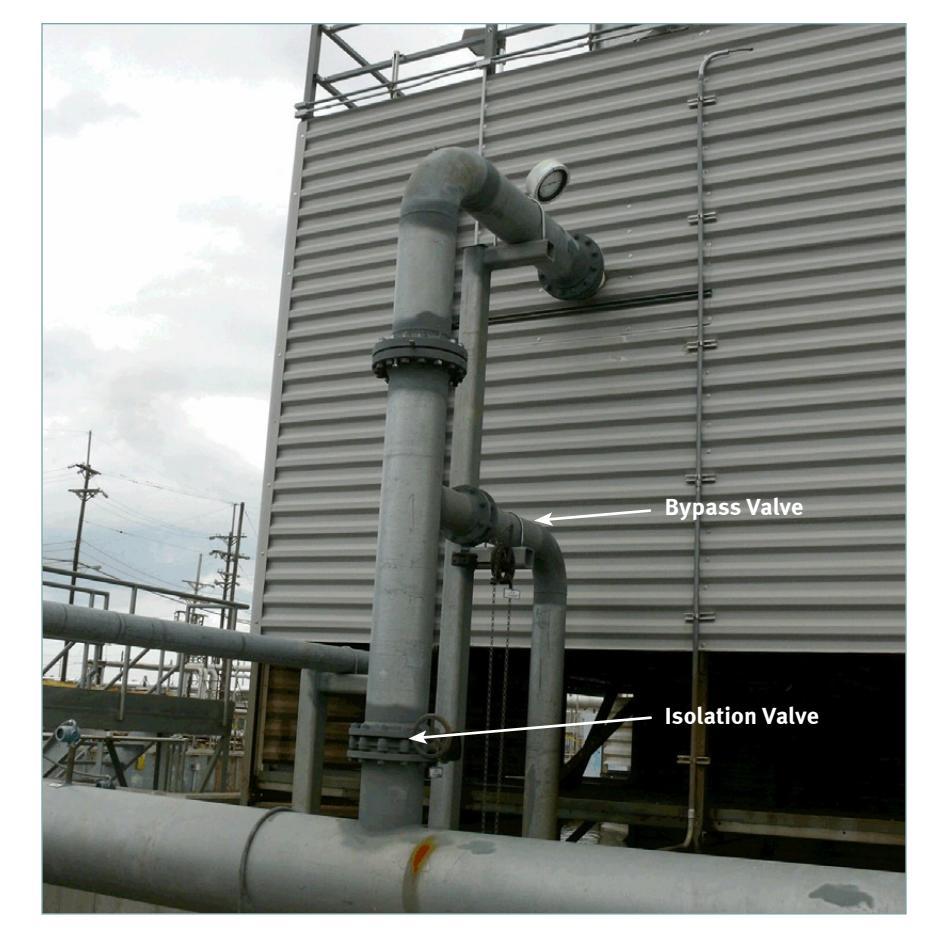
The on-coming operator's good intentions were based on a concern that icing on the cooling tower could result in structural damage. However, she was thinking of older, wooden cooling towers rather than the newer, metal structures, and valve configuration on the newer tower is the opposite of configuration

Figure 2-1. Cooling tower and piping arrangement

on the old tower. This may have contributed to the operator's mistake of isolating cooling water flow and not opening the bypass valves (Figure 2-1). The operator did not have a procedure to follow and received no oral instructions from control room operators or the shift operations manager.

As a result of this event, refresher training on Conduct of Operations will be provided to the cooling tower operators to ensure that each of them has full knowledge and understanding of their associated tasks.
