# Operating Experience Summary

U.S. Department of Energy Office of Health, Safety and Security OE Summary 2008-07 August 7, 2008

## Industry Tower Crane Collapses Lead to Savannah River Site Crane Shutdown

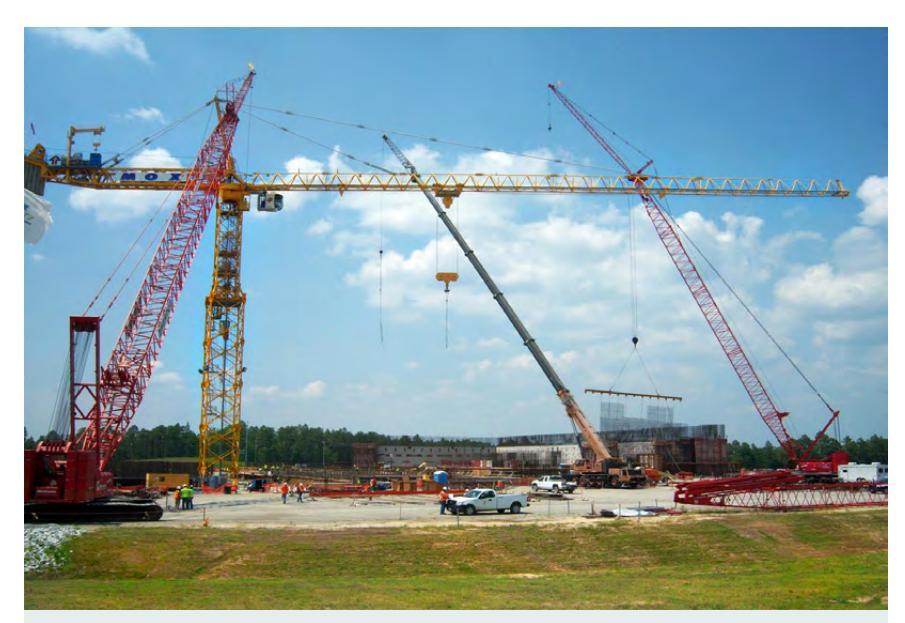
On June 4, 2008, at the Savannah River Site (SRS), a crane operator noticed cracks in the protective coating on two legs of the turntable supports of a tower crane while performing a routine, daily inspection. SRS uses the tower crane and three track cranes for a Mixed Oxide Fuel Fabrication Facility (MOX) project. Figure 1-1 shows the tower crane (yellow) and two of the track cranes (red). The operator notified his supervisor and the crane was shut down immediately, pending further investigation. (ORPS Report NA-SRSO-MOXS-MOX-2008-0004)

Figure 1-1. SRS cranes at MOX Project (yellow tower crane was shut down)

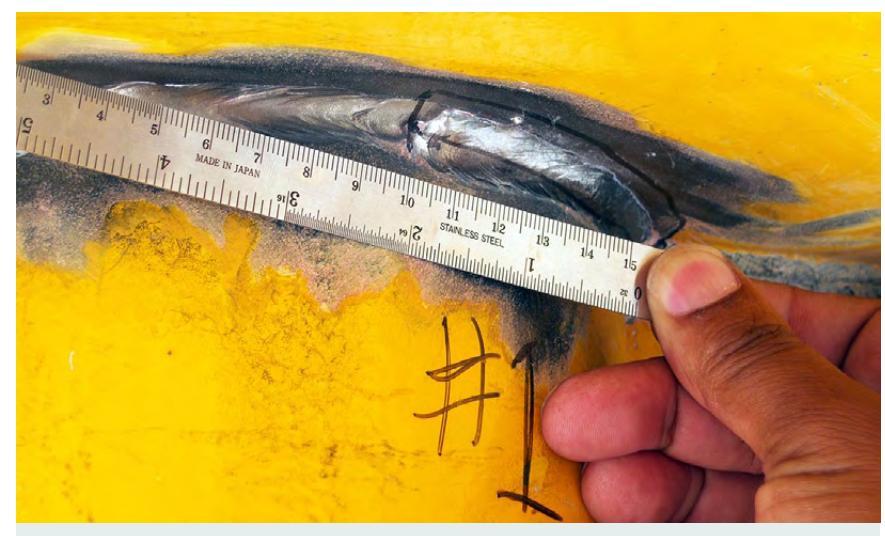
Magnetic particle inspection revealed hairline cracks on two of the four turntable supports (Figure 1-2). Since the cracks were not in a load-bearing component, the manufacturer stated that the crane was safe to operate. However, because of the numerous reports of tower crane accidents across the country, management decided, as a precautionary measure, to use the crane only on a limited basis until repairs are made by MOX personnel and factory representatives following an already scheduled annual crane inspection.

Figure 1-2. Cracks on turntable of SRS tower crane

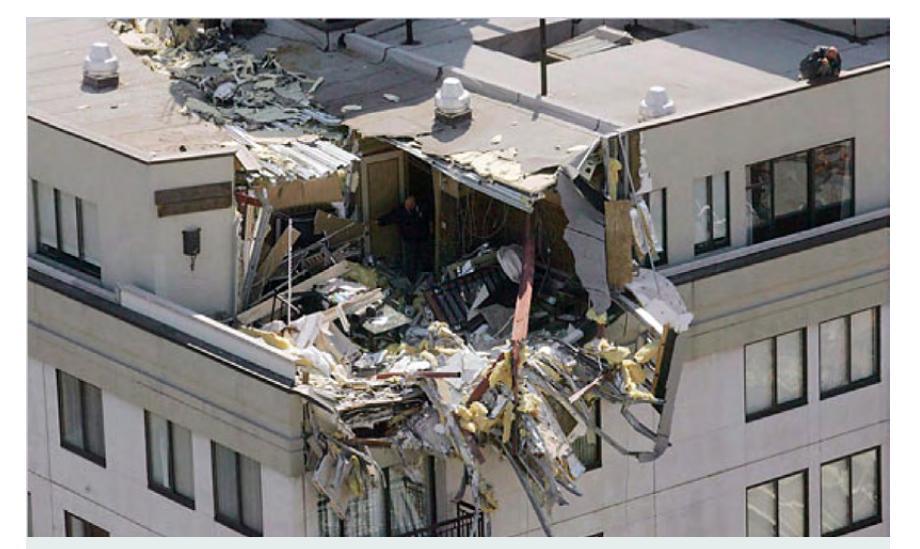
Figure 1-3. Penthouse demolished by May 30, 2008, crane collapse

Another recent crane accident occurred in New York City on May 30, 2008, when the working arm of a crane detached from the tower, fell, and killed two people. Figures 1-3 and 1-4 show the aftermath of that accident. Additional information about this accident is available at a New York Times blog. (http:// cityroom.blogs.nytimes.com/2008/05/30/crane-collapses-onupper-east-side/)

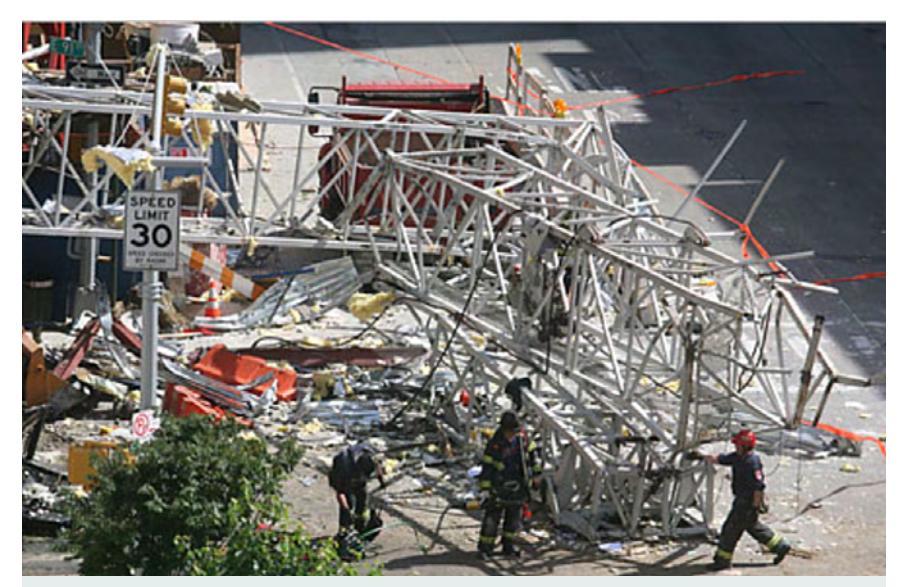
Figure 1-4. Crane on ground following May 30, 2008, accident

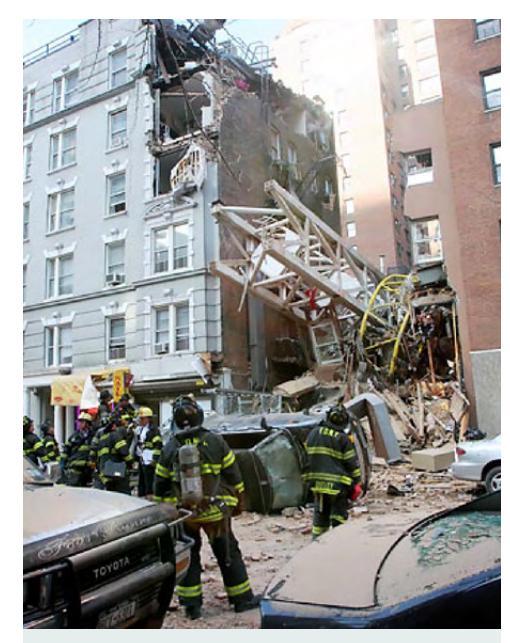
An earlier crane collapse in New York City on March 15, 2008, resulted in 7 deaths and injuries to 24 others, including people in the vicinity of the accident and 11 first responders. Figure 1-5 shows a section of the collapsed crane protruding from the building. The crane collapsed while workers were extending the height of the tower.

Figure 1-5. Collapsed crane protruding from building after March 15, 2008, accident
