Operating Experience Summary

U.S. Department of Energy Office of Health, Safety and Security OE Summary 2009-10 November 6, 2009

Type B Accident Investigation of Hanford Worker Fall from Catwalk

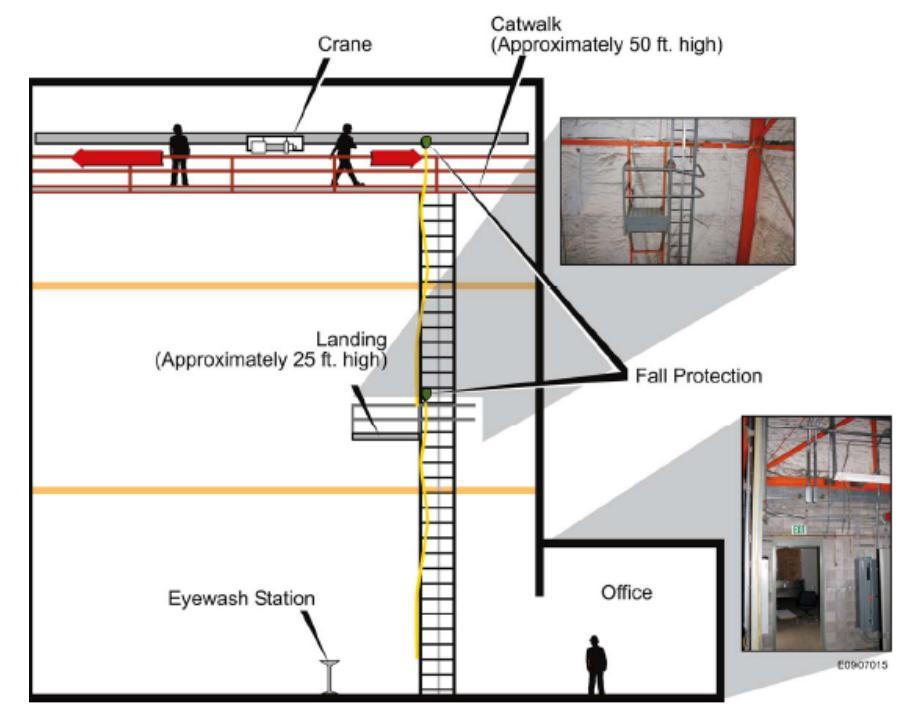
Figure 1-1. Diagram of accident scene

On July 1, 2009, at Hanford, a millwright working on an elevated catwalk to prepare a bridge crane for removal fell through an open hatch to the floor below. As he fell, he struck the guardrail of a midpoint platform 25 feet below the catwalk and then fell another 25 feet to the concrete floor. Figure 1-1 is a diagram of the accident scene. Fortunately, the millwright survived the fall, but he sustained two cracked vertebrae in his back, broken bones in both legs, and damage to his left knee. The millwright was hospitalized for 2 weeks, then was released to continue his recovery at home for several months. A Type B Accident Investigation Board was assigned to investigate this accident. (ORPS Report EM-RL--WCH-DND-2009-0005)

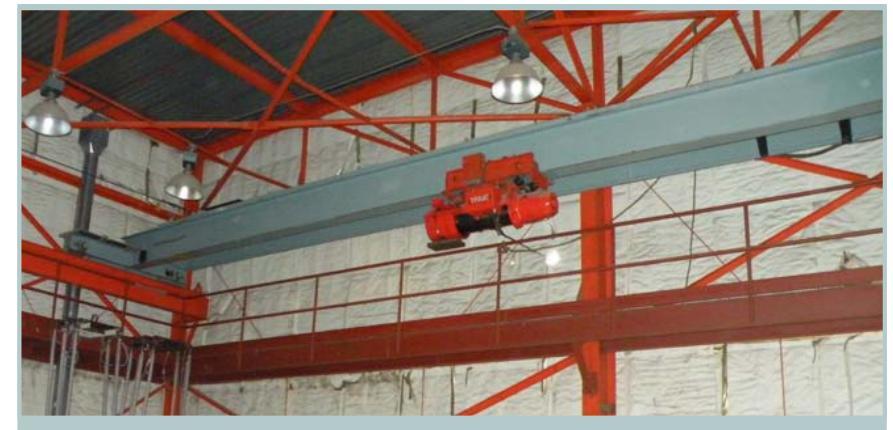
Figure 1-2. Crane and trolley above the catwalk

On the day of the accident, two riggers and two millwrights ascended the ladder to the catwalk and began working. One of the riggers descended from the catwalk and the catwalk hatch to retrieve bottles to collect gear box oil, closing the hatch behind him. Later, one of the millwrights also descended the ladder, leaving the hatch open because he thought the other millwright would follow directly behind him as soon as they had performed the final task of cutting the guardrails. However, after the guardrails were cut, a support rigger on the ground asked the two remaining crew members to secure the crane trolley to the bridge before they descended, which was not part of the original work scope. Figure 1-2 shows the crane and trolley above the catwalk.

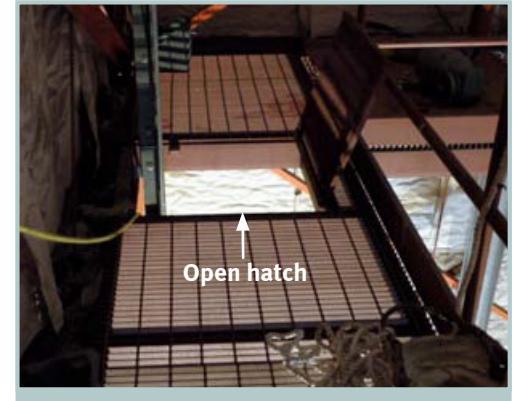
Figure 1-3. Open hatch on the catwalk

The millwright and rigger who had remained on the catwalk decided to bring the crane closer by pushing the crane wheels from both ends of the crane bridge. As the millwright began to walk toward the west end of the catwalk to push the crane wheels, he was focused on the crane and did not notice that the

catwalk hatch had been left open. He stepped into it and fell. Figure 1-3 shows the catwalk and open hatch; Figure 1-4 shows the guardrail at the midpoint after it was bent by the millwright as he fell.

- Ensure that the full scope of work within each work package is comprehensively evaluated and planned, including full and complete walkdowns to identify potential hazards prior to the release of work.
- Clearly delineate the boundaries for skill-of-the-craft work versus detailed planned work, so that hazards are adequately analyzed and controlled.
- Instill a work force culture that ensures that workers understand and take appropriate action when the actual work being performed begins to extend beyond the planned and analyzed work scope.
- Balance the work schedule commensurate with its trained and qualified work force, continually assess work force capabilities and limitations, and apply them to perform work safely.

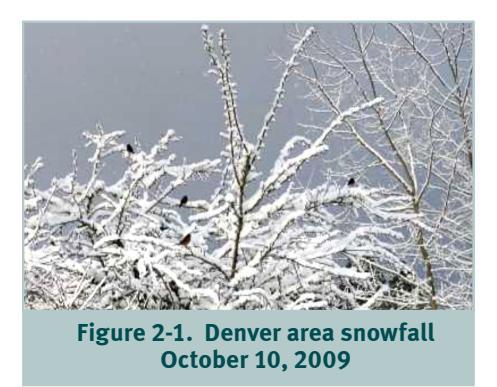
Winter weather is once again on its way, and some areas of the country have already had sub-freezing temperatures, snow, and freezing rain. Denver, Colorado, for example, set a new record low temperature of 17 degrees on October 10, 2009, along with an early snowfall

(Figure 2-1), and on October 29, the area received nearly 30 inches of snow. So, it is time to start preparing facilities for weather-related hazards and to begin reminding employees to use caution when walking and driving on icy roads and walk-ways. The following events from the winter of 2008/2009 show the types of problems that inclement weather brings.
