OPERATING EXPERIENCE SUMMARY

U.S. Department of Energy Office of Health, Safety and Security OE Summary 2011-08 November 4, 2011

Avoid Lifting Incidents: Use a Crane Rated for the Load

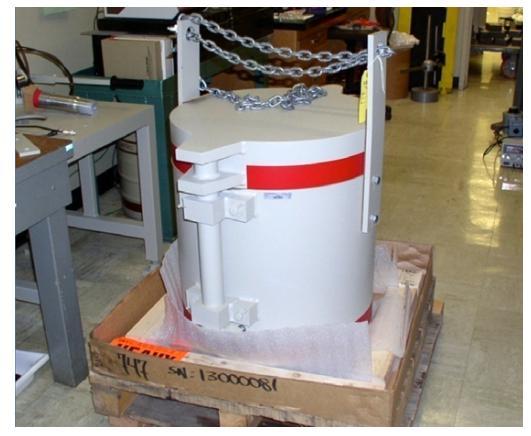
On December 9, 2010, at the Lawrence Livermore National Laboratory (LLNL) Physical and Life Science Directorate (PLS), two workers threaded a chain through the lifting arm anchor holes of a 2,600-pound lead shielding cover and attempted to lift it with a portable shop crane that was undersized for the weight of the shielding. Figure 2-1 shows the shielding cover, and Figure 2-2 shows the undersized shop crane. The workers had placed approximately 18, 25-pound lead bricks at the rear of the hoist to provide stability and a counterbalance, but once they began the lift, they realized that they could not reach the desired height because of the weight of the cover and the configuration of the lifting operation. When the cover was approximately 1.5 feet off the ground, a Health and Safety Technician came into the area and told the workers to lower the load because of safety concerns. (ORPS Report NA--LSO-LLNL-LLNL-2010-0061; final report issued January 24, 2011)

Figure 2-1. 2,600-pound lead shielding cover (note chain threaded through lifting arms)

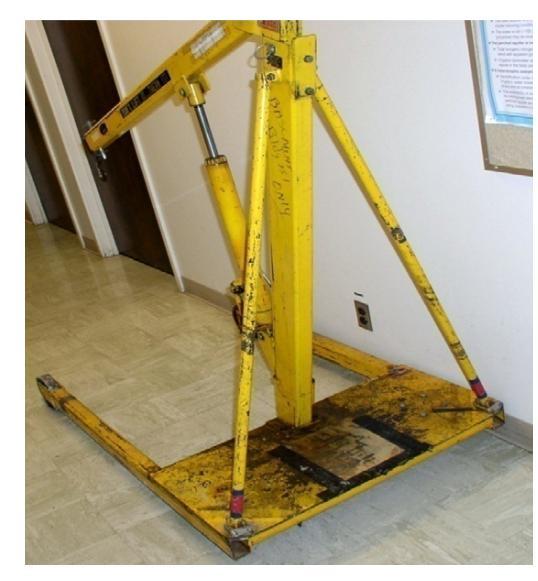
After work was stopped, an Industrial Safety Engineer determined that the crane was not suitable for the lift. The metal plate on the unit, which lists the model number and capacity, was unreadable, but it was clear that the crane was not rated for the 2,600-pound lead shielding cover and that using an unrated chain threaded through the lifting arm anchor holes instead of a spreader bar was not an appropriate lift configuration. PLS Management identified this event as a near miss and initiated a management review to determine what led to the event.

Figure 2-2. Shop crane used in the attempted lift

Following this event, the shop crane was tagged out of service to ensure that it would not be used for any lifting activities in the future. Management also developed a number of corrective actions to address the identified organizational weaknesses. Because neither worker was properly trained or qualified to perform the lift, they will be appropriately trained and qualified for performing similar future tasks. In addition, management will have all work supervisors review their Integration Work Sheets to ensure that the training requirements for lifting are identified and all affected employees are current with their training.
