**DEFENSE NUCLEAR FACILITIES
SAFETY BOARD**

April 4, 2016

Staff Issue Report

SUBJECT: Waste Treatment and Immobilization Plant Quality Assurance Review

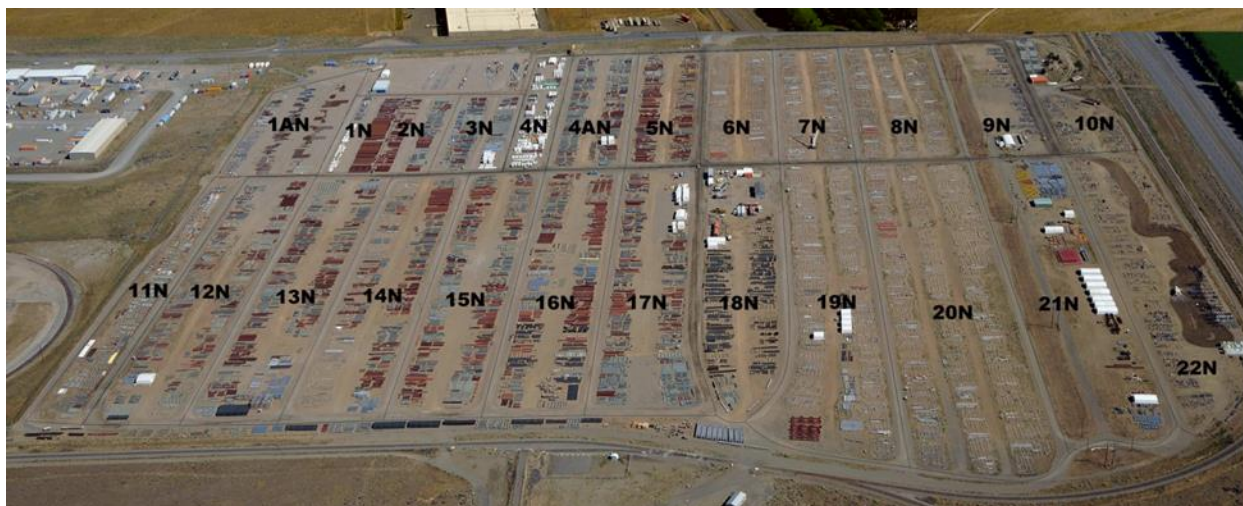
Figure 1. An aerial photograph of the 130 acre MHF Laydown Yard located in Richland, Washington. The MHF Laydown Yard includes 10 miles of roadway, 24 storage rows (labeled in the photograph), 106,154 items, and 15,077 tons of structural steel. Approximately 47 and 50 percent of these SSCs are for the Pretreatment and High-Level Waste Facilities, respectively.
