OPERATING EXPERIENCE SUMMARY

Office of Environment, Safety and Health OE Summary 2002-16 August 12, 2002 The Office of Environment, Safety and Health (EH), Office of Performance Assessment and Analysis publishes the Operating Experience Summary to promote safety throughout the Department of Energy (DOE) complex by encouraging the exchange of lessons-learned information among DOE facilities.

Operating Experience Summary 2002-16

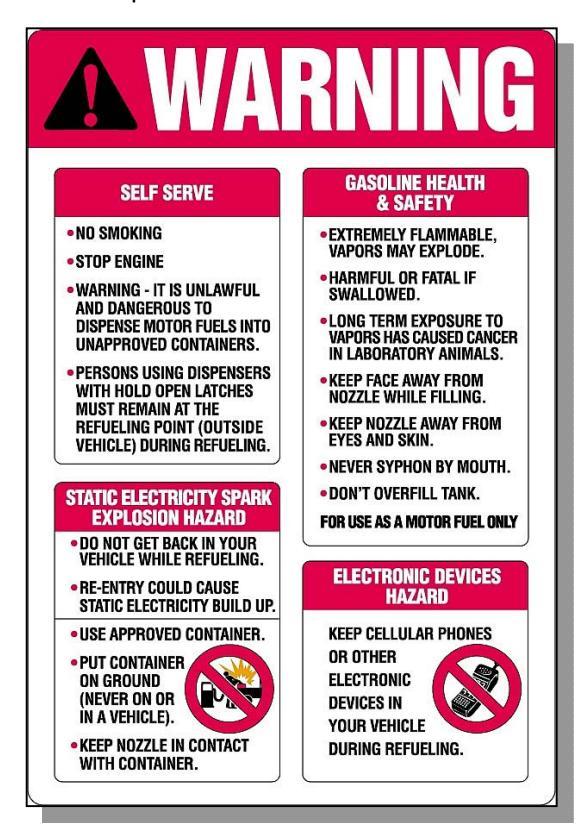
Figure 3. Revised warning placard

Other organizations within the petroleum industry are aware of this problem; for example, the American Petroleum Institute has implemented a public awareness campaign to warn and educate the public on the potential hazards of static electricity at the fueling point. Some distributors have revised warning labels and placards and are installing them on gasoline pumps. Figure 3 shows a revised placard that includes hazard warnings for static electricity and electronic devices. The lesson learned from this issue is that static electric discharge near gasoline pump nozzles can ignite vapors near the fill port and cause serious fires. People pumping gas should avoid reentering the vehicle while refueling. If they must re-enter the vehicle, they should touch a metal part of the vehicle located away from the fill port before touching the nozzle to discharge the static electricity. When filling gasoline containers, remove the container from the vehicle and place it on the ground before filling. In addition, avoid using cellular telephones or other electronic devices while pumping gas or when near potentially explosive atmospheres.
