OPERATING EXPERIENCE SUMMARY

**U.S. Department of Energy
Office of Environment, Safety and Health**

OE Summary 2003-05

March 10, 2003

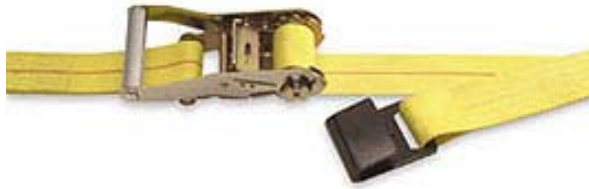
Figure 3-3. A typical ratchet tie-down strap

Inspectors found all the other bolts on the tie-down straps to be satisfactory. The transport vendor was asked to examine its remaining inventory of ratchet lever tie-down straps and to contact its supplier(s) to determine the origin of the strap. In an ongoing investigation at WVDP, investigators have identified four additional ratchet lever tie-down straps with suspect/counterfeit bolts. The manufacturer of the tie-down strap in this event is Kinedyne. A typical tie-down strap is shown in Figure 3-3.
