OPERATING EXPERIENCE SUMMARY

U.S. Department of Energy
Office of Environment, Safety and Health

OE Summary 2003-15

July 28, 2003

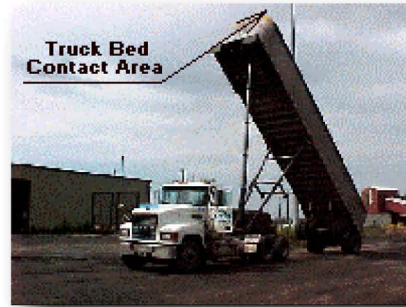
The Department of Labor Mine Safety and Health Administration issued an Info-Gram (www.msha.gov/District/Dist_08/powerlin.htm) on a September 2000 event at a surface mine, where the raised bed of a large dump truck contacted an energized 13,200-volt power line. A witness attempted to warn the truck driver to remain in the cab until the power could be verified off; however, he did not heed the warning and exited the truck. Fortunately for the driver,

relays in an electrical substation had de-energized the power line or he could have been electrocuted.
