OPERATING EXPERIENCE SUMMARY

U.S. Department of Energy
Office of Environment, Safety and Health
OE Summary 2003-18
September 8, 2003

Operating Experience Summary 2003-18

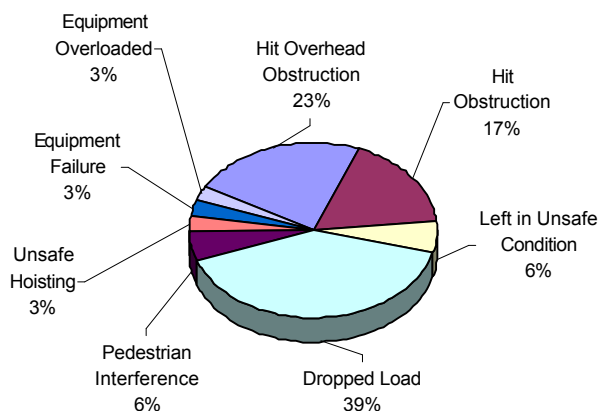
Figure 2-1. Distribution of event causes

The Office of Environment, Safety and Health reviewed 33 forklift events reported from January 2002 through August 2003. Seventy-three percent of these events occurred during normal facility operations, including transportation activities. The following chart (Figure 2-1) shows the distribution of causes for these events. Hitting obstructions and dropping loads accounted for 79 percent of the forklift incidents. Fortunately, none of these were tip-over accidents, which are a major cause of injury or fatality.
