OPERATING EXPERIENCE SUMMARY

U.S. Department of Energy
Office of Environment, Safety and Health
OE Summary 2004-07
April 5, 2004

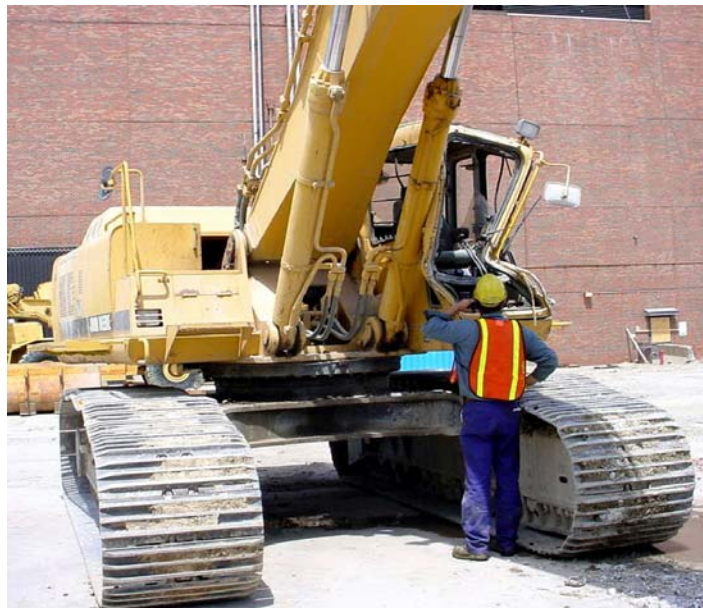
Figure 1-2. Damage to the excavator

Figure 1-2 shows the extent of the damage to the excavator. An investigation disclosed that the breezeway collapsed because the supporting base plates were not bolted in place when it was constructed in the 1950s (Figure 1-3), although the construction drawings indicated that they were. The excavator operator had helped demolish two other buildings and their breezeways, and in both of those cases the breezeway base plates were bolted down.
