Operating Experience Summary

U.S. Department of Energy
Office of Environment, Safety and Health
OE Summary 2005-14
November 16, 2005

1. *BE AWARE OF OVERHEAD ELECTRICAL LINES WHEN OPERATING DUMP TRUCKS*

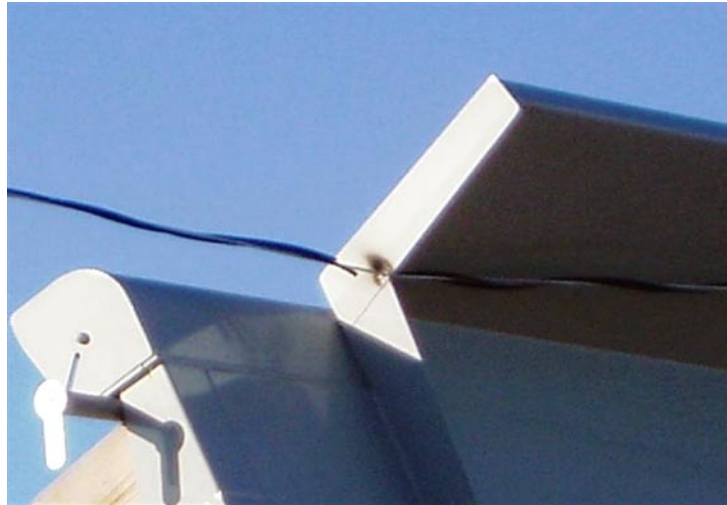
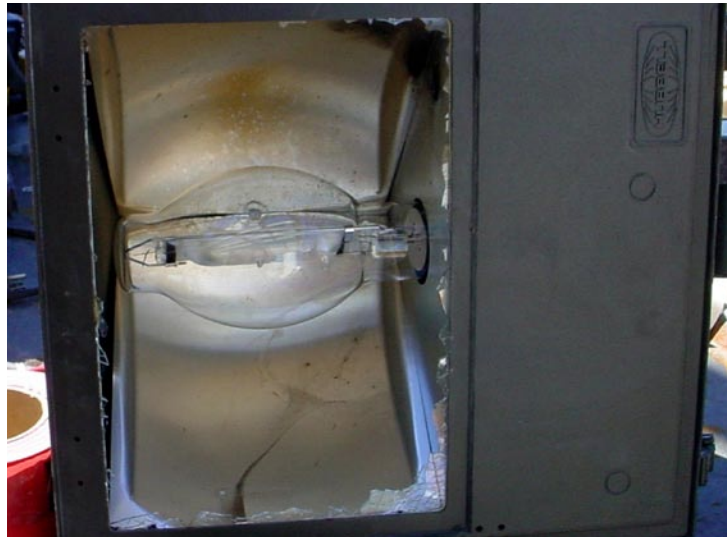
On September 21, 2005, at the Hanford Central Waste Complex, the raised bed of a dump truck operated by a subcontractor hit an energized 240-volt power line, producing an electrical arc as the line was severed. The driver exited the truck without waiting for verification that the line was de-energized, but was not injured. Equipment damage was limited to the cut power line. (ORPS Report EM-RL--PHMC-SOLIDWASTE-2005-0010)

When the driver realized he had hit the power line, he exited the truck before he knew whether

the power line had been de-energized. Neither the driver nor the Operations Lead recognized that this was not a safe practice or realized the potential for electrocution. Electrical Utilities personnel de-energized and repaired the power line after the truck was moved away.
