OPERATING EXPERIENCE SUMMARY

U.S. Department of Energy
Office of Health, Safety and Security
OE Summary 2006-13
November 17, 2006

Failure to Wear Proper Personal Protective Equipment Results in Arc Flash Injury

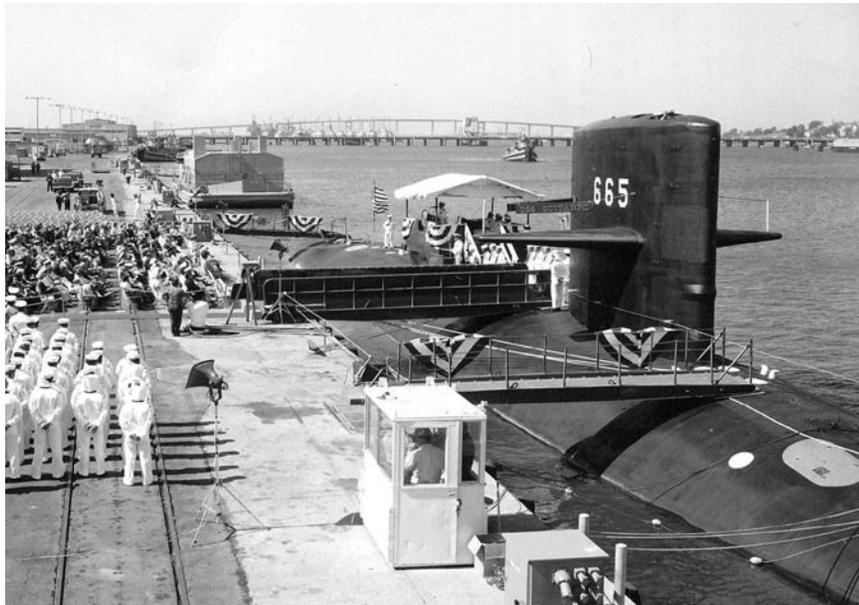
A security watch on the submarine became concerned that the ship was riding low in the bow and that wave action from passing boats caused water to enter an open manhole used to access the sonar dome in the nose of the submarine. The security watch told the non-nuclear group about his concern but failed to notify his superiors as required by regulations. His warnings were ignored by the non-nuclear group, who only stopped adding water to the forward ballast tanks when it was time to take their lunch break. While they were at lunch, the nuclear group completed their calibrations and began to empty the aft tanks. This caused the stern of the ship to become more buoyant and rise and the bow to sink even further because of the water that had been added to forward ballast tanks. A half-hour later, the submarine took a sharp downward angle

Figure 4-2. USS Guitarro at commissioning. Notice the ship's normal trim and waterline.

as massive flooding occurred through open hatches. Workers attempted to close watertight doors and hatches to isolate compartments, but were unsuccessful because cables and lines had been routed through openings, allowing the submarine to fill with water and sink in the river along side the dock.
