OPERATING EXPERIENCE SUMMARY

U.S. Department of Energy
Office of Health, Safety and Security
OE Summary 2007-05
July 16, 2007

Inside This Issue

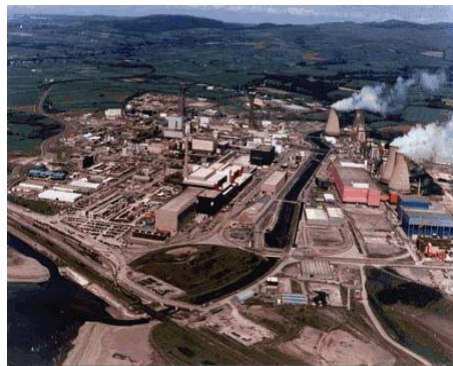
On February 23, 2007, the Health and Safety Executive (HSE) published a report on its investigation of the internal leak of highly radioactive liquid at the Thermal Oxide Reprocessing Plant (THORP) in northwestern England. HSE is the enforcement authority for Great Britain's Health and Safety Commission and their report includes lessons that are applicable to DOE operations.
