OPERATING EXPERIENCE SUMMARY

U.S. Department of Energy
Office of Health, Safety and Security
OE Summary 2008-08
September 4, 2008

Plutonium Spill at Boulder NIST Facility

Unsafe Liftgate Operation Results in Worker Injuries

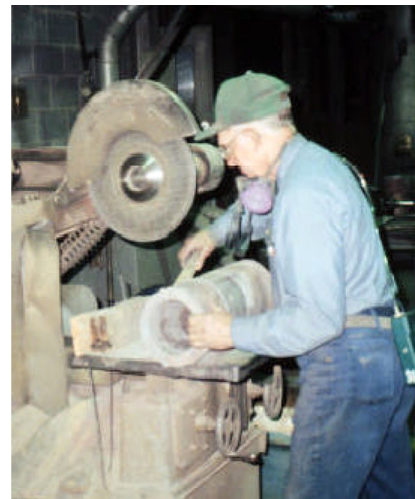
Figure 3-1. Example of older worker engaged in work task

Like the worker shown in Figure 3-1, many U.S. workers are now 55 years of age or older. According to research published in the *Monthly Labor Review*, the share of the labor force of the 55 and older age group was expected to increase from 14.3 percent (2002) to 19.1 percent (2050), and the percentage of workers 55 to 64 and over 65 would grow by 48 percent and 40 percent, respectively, between 2002 and 2012. (<http://wistechology.com/articles/3807/>)
