OPERATING EXPERIENCE SUMMARY

U.S. Department of Energy
Office of Health, Safety and Security
OE Summary 2009-06
June 25, 2009

Worker Injured When Length of Safety Line Exceeds Distance of Fall

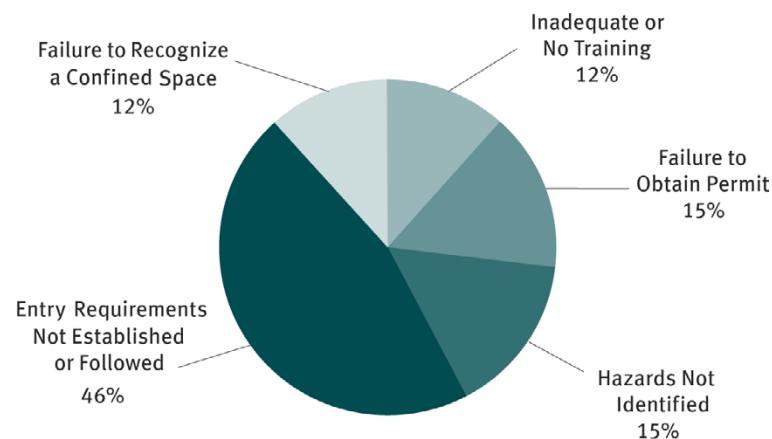
Figure 2-2. Distribution of commonly made confined space mistakes 2000–2007

OE Summary 2008-01 also discusses a review of confined space issues reported to ORPS over a 7-year period between 2000 and 2007, which indicated that nearly 50 percent of the events occurred because entry requirements either were not established or were not followed. Figure 2-2, taken from the article, shows the distribution of commonly made errors.
