OPERATING EXPERIENCE SUMMARY

U.S. Department of Energy
Office of Health, Safety and Security
OE Summary 2009-09
October 2, 2009

Seemingly Unimportant Changes Result in Crane Accidents

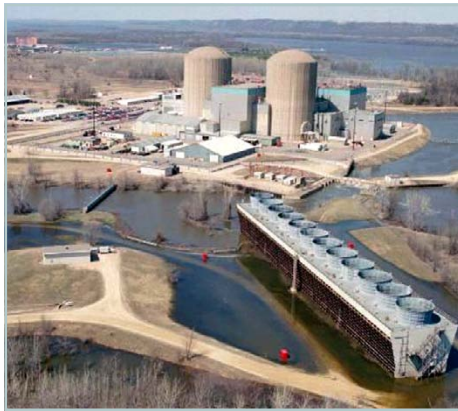
Figure 2-1. Prairie Island Nuclear Generating Plant

On July 31, 2008, following an inadvertent reactor trip of Prairie Island Unit 1, the turbine-driven AFW pump automatically started as designed, but tripped 42 seconds later on low discharge pressure. Plant personnel discovered that the isolation valve for the discharge pressure switch was closed instead of open as required. A time delay in the pump protective

circuitry trips the pump when a continuing low discharge pressure condition exists. The monthly surveillance to test the operability of the pump does not test the low discharge pressure trip function because the pump is tested in the manual operating mode, which bypasses the low discharge pressure trip.

The improper isolation of the turbine-driven AFW pump discharge pressure switch resulted from the failure to adequately control components that affect the operability of safety-related equipment. The following causes were identified.

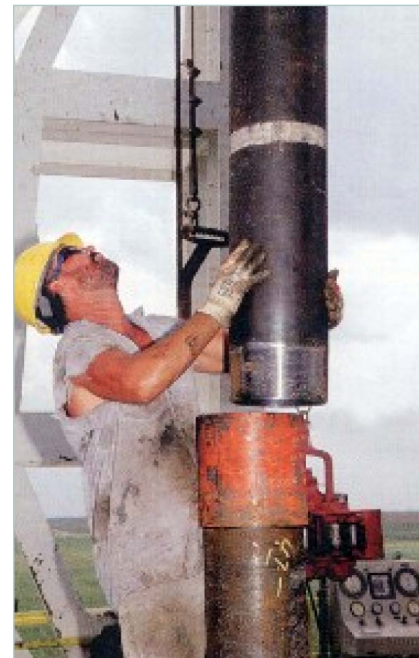
Figure 3-2. Casing being prepared for use on an oil rig

The workers used the U-plate (i.e., a hold-fast device) to suspend a 12-inch casing from the top of a 16-inch casing when the 12-inch casing was disconnected from the drill rig. Casing is a pipe (larger in diameter and usually longer than the drill pipe) that is used to line a hole to maintain the well opening. Figure 3-2 shows a casing being prepared for use on an oil rig.
