OPERATING EXPERIENCE SUMMARY

U.S. Department of Energy
Office of Health, Safety and Security
OE Summary 2010-05
September 1, 2010

Fatal Accident at White Bluffs Substation — The Investigation Results

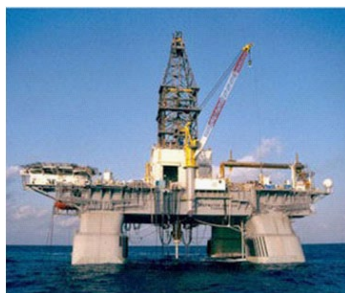
Figure 2-1. Deepwater Horizon prior to explosion

On April 20, 2010, an explosion and fire erupted on an offshore drilling rig called the Deepwater Horizon, located in the Gulf of Mexico (Figure 2-1), where an exploratory well had just been completed 52 miles from shore in 4,992 feet of water. Eleven crew members were killed in the explosion; the remaining crew members abandoned the rig and were rescued by a nearby supply vessel. The fire destroyed the rig (Figure 2-2), which sank on April 22, 2010.

A failed blowout preventer (BOP) on the Deepwater Horizon drilling platform appeared to be the primary cause of the spill, which is one of the worst disasters in the history of oil production.
