OPERATING EXPERIENCE SUMMARY

U.S. Department of Energy
Office of Health, Safety and Security
OE Summary 2011-01
February 2, 2011

Type B Accident Investigation: Technician Punctures Hand During TRU Waste Remediation Activities

No Way Out—Five Workers Die in Confined-Space Tunnel Fire

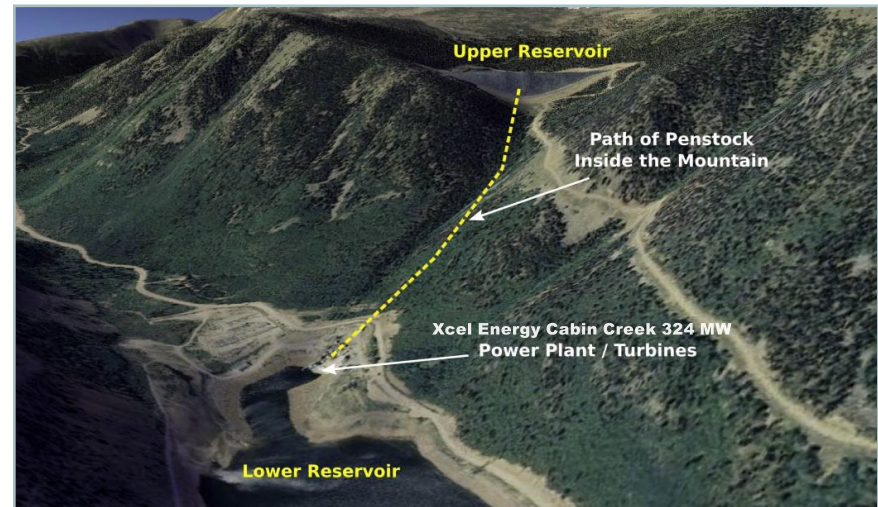
On October 2, 2007, at Xcel Energy's Cabin Creek 324-mega-watt (MW) hydroelectric plant in Georgetown, Colorado, a remote mountain location 45 miles west of Denver, contractors from RPI Coating, Inc., were painting a 1,530-foot steel portion of a 4,300-foot enclosed penstock (tunnel) when a chemical fire broke out. Five of the contractors died in the fire, and three others were injured. The contractors were using waterproof epoxy to resurface the tunnel walls and floor when the fire erupted. The cause of the fire is believed to be a static spark that ignited flammable solvent used to clean the epoxy application equipment in the open penstock atmosphere. Figure 2-1 shows the overall layout of the Xcel plant, and Figure 2-2 shows the configuration of the penstock, which directs water from an elevated reservoir to the turbines in the powerhouse.

The fire quickly grew as it ignited the buckets of solvent and substantial amounts of combustible epoxy material used in the project. Five of the 11 workers were blocked from accessing the single point of escape within the penstock, a flame-cut access door made by the contractors for moving supplies and equipment into the tunnel. See Figure 2-2 for a graphic of the door's location in relation to the plant configuration (upper right inset), and Figure 2-3 for a photograph showing the actual construction. Workers not trapped by the fire scrambled for extinguishers at the tunnel's entrance, but were unable to fight the thick smoke and intense heat. Fourteen community response teams responded to the incident. The five trapped workers used handheld radios to communicate with co-workers and emergency responders for approximately 45 minutes before they succumbed to smoke inhalation.

Figure 2-1. Arrangement of power plant, reservoirs, and penstock pathway
