DEFENSE NUCLEAR FACILITIES SAFETY BOARD

SUBJECT: Report on the Radiation Protection Review at the Rocky Flats Plant

1. **Purpose:** This memorandum documents the Defense Nuclear Facilities Safety Board (DNFSB) technical staff and outside expert trip to the Rocky Flats Plant to review the Radiation Protection Program. The review was based on a visit to Rocky Flats on August 16-20, 1993.
2. **Summary:** The staff reviewed the Radiation Protection Program for consistency with Department of Energy (DOE) Order 5480.11, *Radiation Protection for Occupational Workers*, DOE Notice 5480.6, *Radiological Control*, and DOE Order 5400.5, *Radiation Protection of the Public and the Environment*.

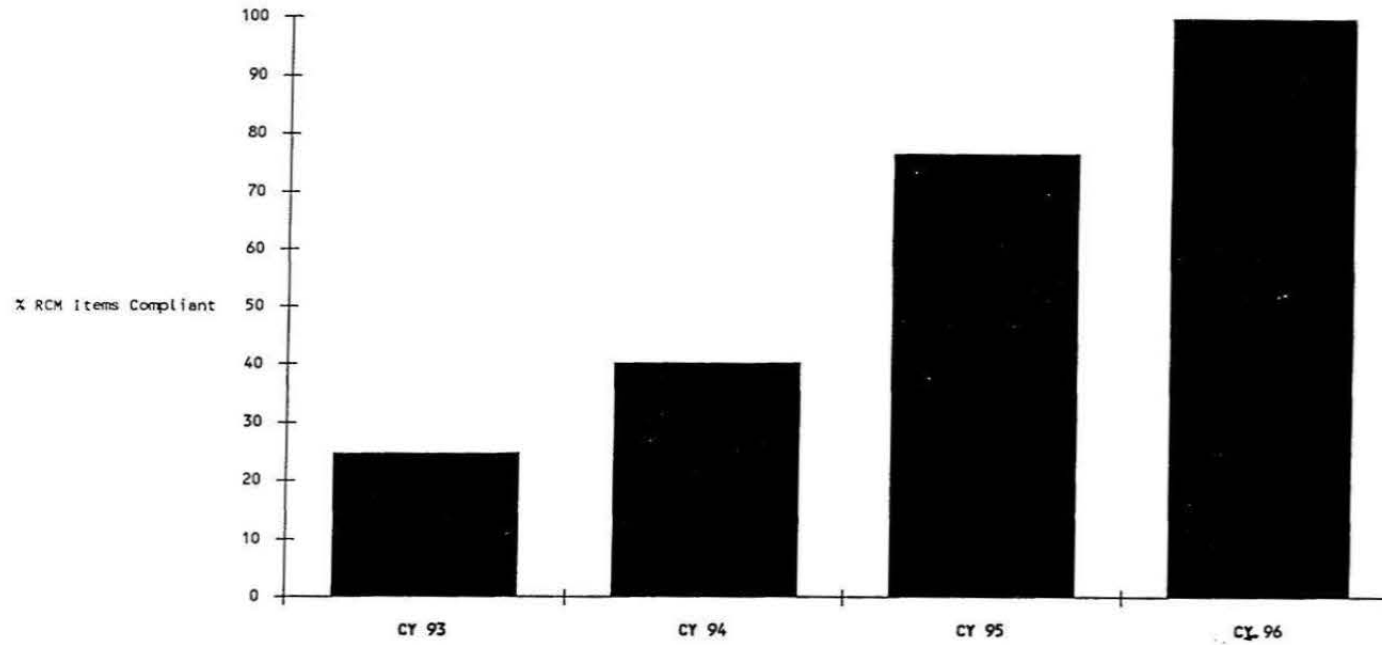
RCM Implementation at the RFP
Per Cent Compliant at End of Year

Note: Graph was based on the Implementation Plan Summary, and does not reflect the information provided by the Implementation Plan Schedule which shows some activities with completion dates in 1997 and 1998.

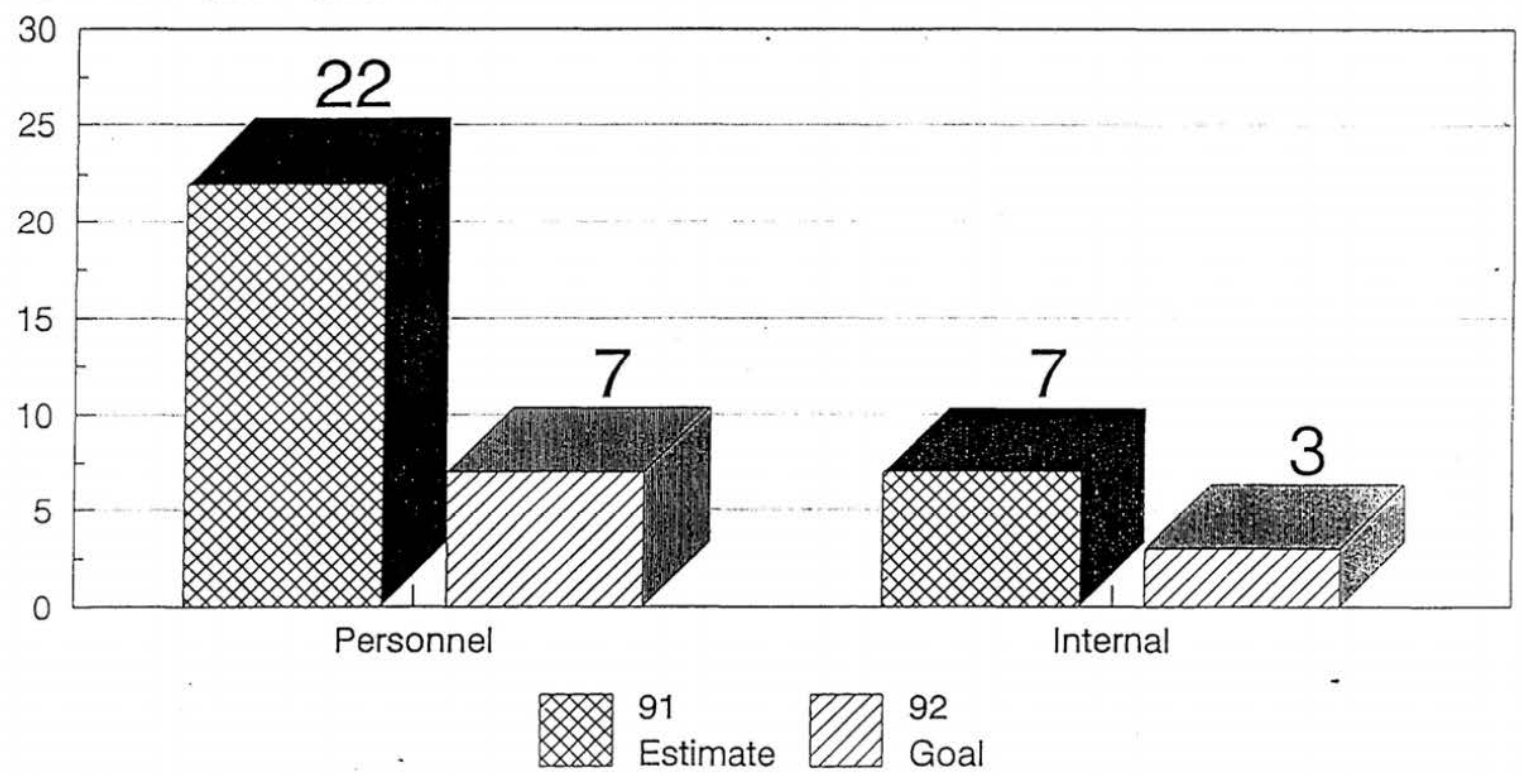
Personnel/Internal Contamination Totals

1992 ALARA Goals Summary

Contaminations

ALARA Program Performance Indicators were presented in the following areas: 1) Personnel Cumulative Radiation Exposure, 2) Confirmed Intakes greater than 100 mrem CEDE, 3) Skin/Clothing and Area Contaminations and 4) Number of Individuals Exceeding Administrative Dose Guidelines (ADG). The following observations were made during the review:

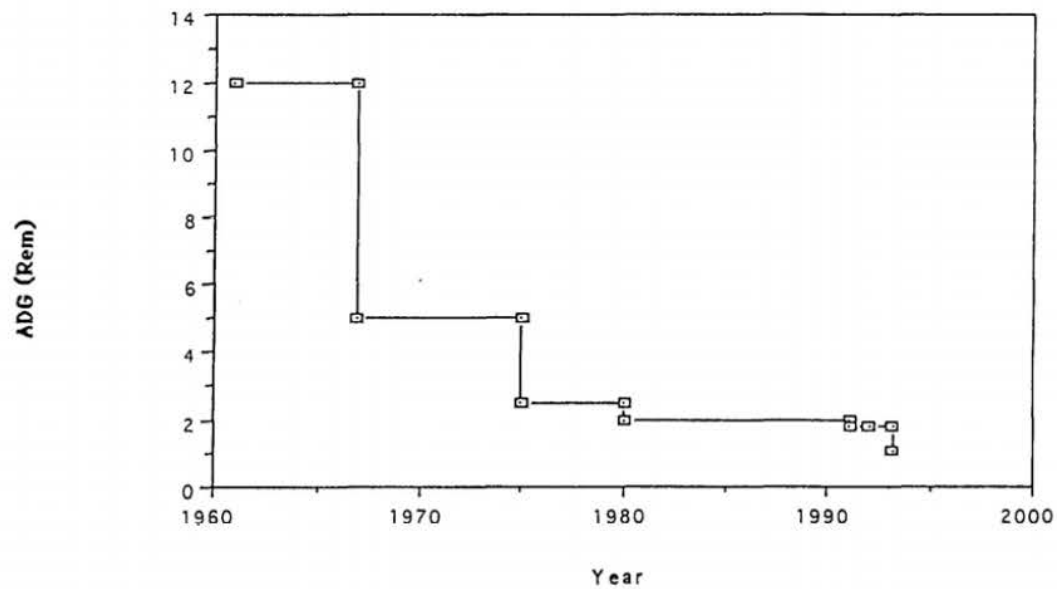
History of RFP Administrative Dose Guides (ADG's)

Rocky Flats ADG History
