Attached is the report, "Analysis and Trending of Suspect/Counterfeit Items at Department of Energy Facilities." This report fulfills a commitment to the Board to develop a semi-annual suspect/counterfeit items (SC/I) report documenting actions taken by the Department in response to potential S/CI issues.

ANALYSIS AND TRENDRING OF SUSPECT/COUNTERFEIT ITEMS AT DEPARTMENT OF ENERGY FACILITIES

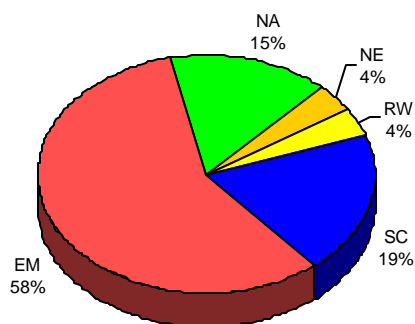
Figure 3. S/CIs by Program Office – 2003 First Half (ORPS only)

When sorted by Program Office, Environmental Management (EM) accounted for 58% of the reported occurrences, Science (SC) accounted for 19% of the reported occurrences, National Nuclear Security Administration (NA) accounted for 15% of the reported occurrences, and Civilian Radioactive Waste Management (RW) and Nuclear Energy (NE) each accounted for 4% of the reported occurrences. None of the other Program Offices reported any S/CI events. Figure 3 shows this breakdown by Program Office for 2003. The results are similar to the S/CI events reported by Program Office in 2002 as shown in Figure 4.

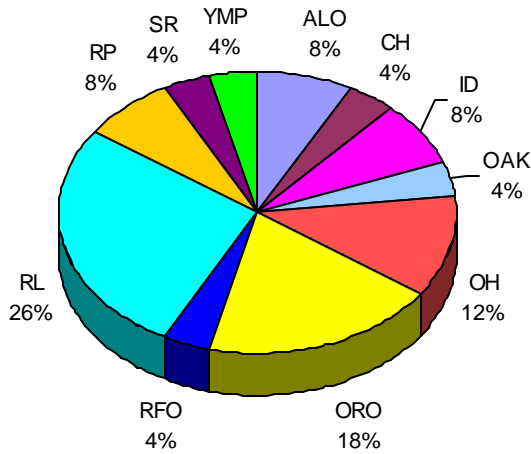
Figure 5. S/CI by Operations/Field Office – First Half 2003 (ORPS only)

The distribution of S/CI for the first six months of 2003 by Operations/Field Offices was as follows: Richland Operations Office (RL) 26%; Oak Ridge Operations Office 18%; Ohio Field Office (OH) 12%; Idaho Operations Office (ID) 8%; River Protection Office (RP) 8%, Albuquerque Operations Office (ALO) 8%; and other remaining Offices combined 20%. Figure 5 displays these results. Figure 6 illustrates the S/CIs by Operations/Field Office for 2002.

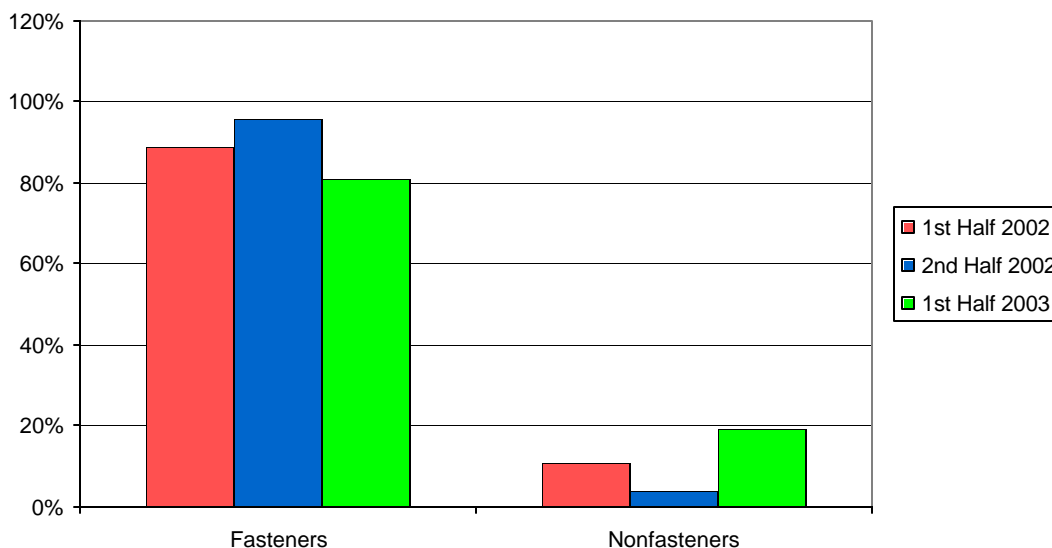
Figure 9. Fasteners vs. Non-fasteners, 2002-2003 (ORPS only)

During the period from January 1991 through December 2002, 92% of the reports submitted refer to fasteners; thus, the emphasis on suspect/counterfeit (S/C) fasteners was justified. . During the most current period (January 1 through June 30, 2003), 81% of the reports involved fasteners. However, items such as valves, circuit breakers, test equipment, or memory modules, for example, could be as important as, or more important than, fasteners in terms of potential adverse impact to safety systems

ORPS reports identified between January 1991 and June 2003 were reviewed for the following parameters and illustrated in Figures 9 through 12.

- ? Usage: Used as fastener or non-fastener.
- ? Application: Used in safety or non-safety system equipment.
- ? Installed vs. Uninstalled: Found in an installed condition; or uninstalled, (e.g., found in storage or during receipt inspection).
- ? Corrective Action: The programmatic or immediate actions taken.

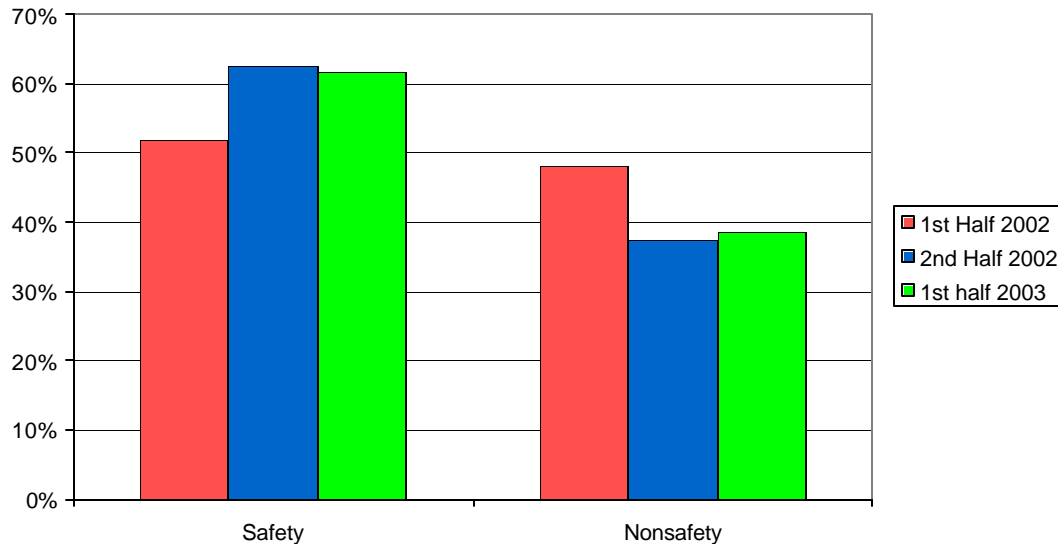
Figure 10. Safety vs. Nonsafety Applications, 2002-2003 (ORPS only)

Components discovered in site stores or during receipt inspection are categorized as a non-safety application if they were never used to perform a safety function. During the period (January 1 through June 30, 2003), 38% of the reports involved non-safety system applications.
