**TRANSMITTAL OF DEFENSE NUCLEAR FACILITIES SAFETY BOARD  
RECOMMENDATION 2012-2 IMPLEMENTATION PLAN DELIVERABLE  
FOR ACTION 1-3**

**RPP-RPT-58120, Rev. 0: INSPECTING THE DST PRIMARY TANK  
VENTILATION SYSTEM**

# Inspecting the DST Primary Tank Ventilation System

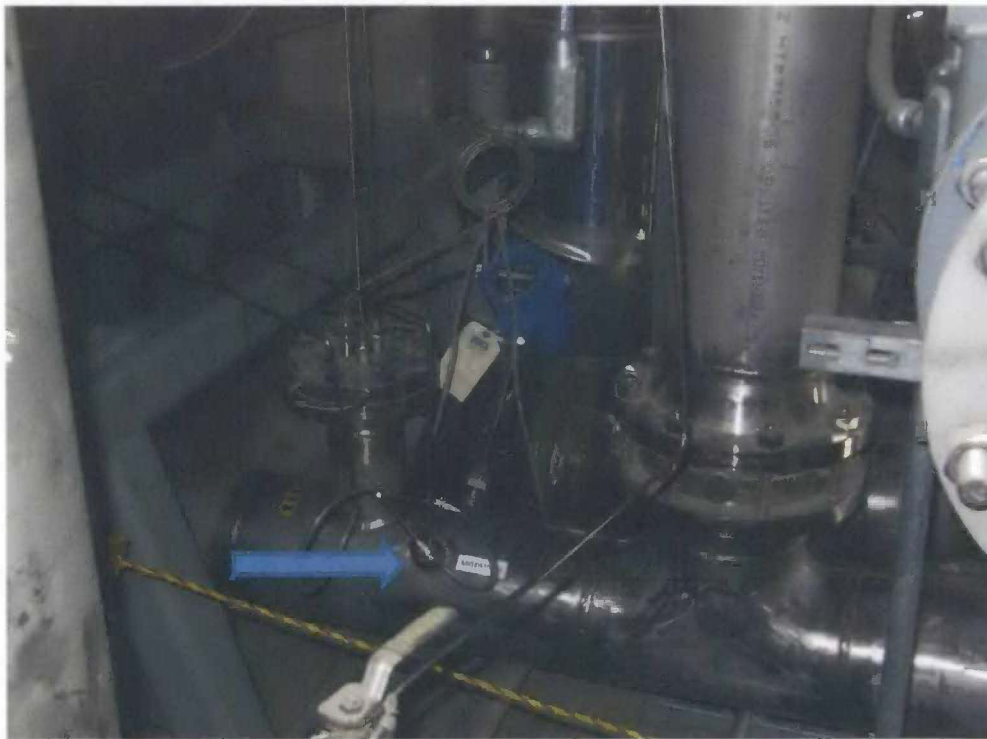
**Figure 4: AZ-102 Flow Test Ports**

Like the Type 1 configurations, the flow test ports for the Type 2 configurations consist of two 0.75-inch ports with a 1.5-inch plug to seal the port when not in use. Figure 4 shows the flow test ports in the AZ-102 duct.

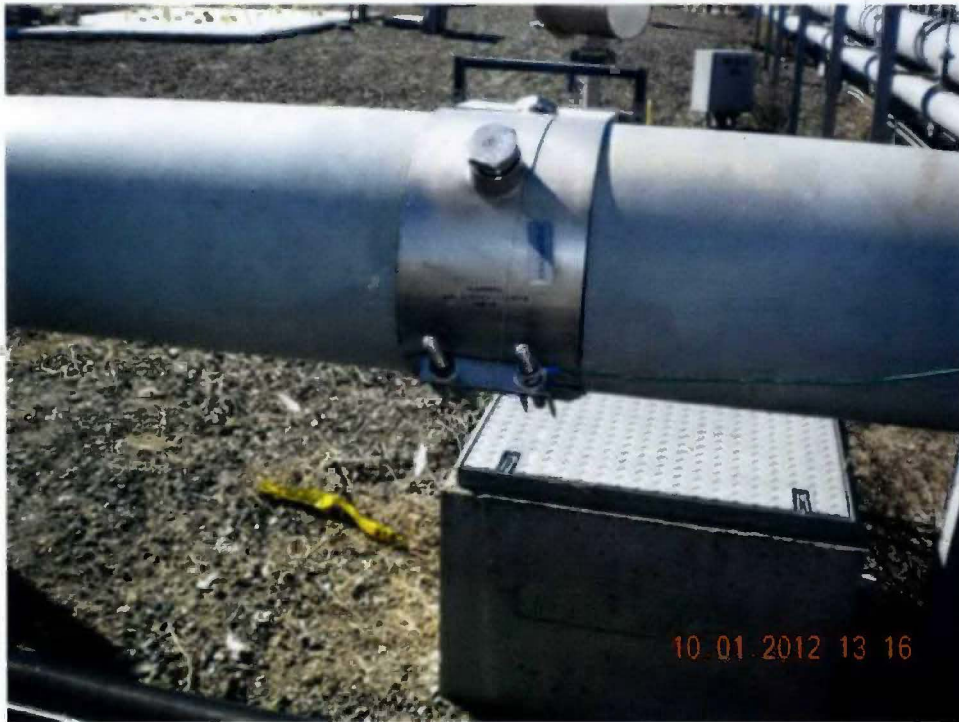
**Figure 5: SY Farm Primary Ventilation Duct Flow Test Ports**

The three SY DSTs have Type 3 primary ventilation ductwork. Type 3 primary ventilation ductwork is all above ground except at tank dome penetrations. The flow test ports for Type 3 ductwork, like Type 1 ductwork, are limited to small ports installed in recent years (ECN-12-000466). These flow test ports are very similar to the Type 1 and Type 2 flow sample ports in that they consist of two 0.75-inch ports installed directly into the ducts. Figure 5 is a photo of typical flow test ports installed in the SY farm ductwork.

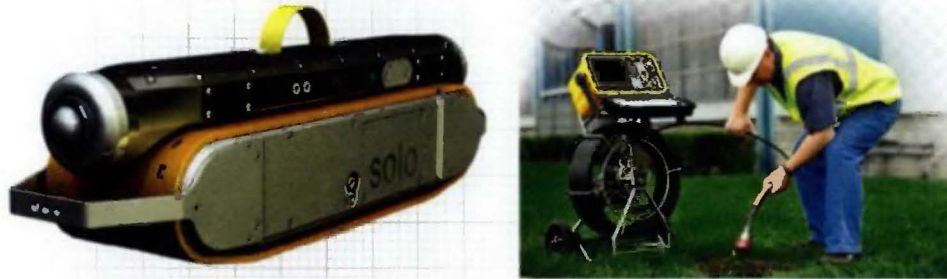
**Figure 6: Typical Visual Inspection (ROV - Left, Borescope - Right)**

Visual inspection consists of a camera and lighting. The camera is installed on borescopes, crawlers, or poles that can be deployed into pipes. This can provide information about the condition of the pipes, but it is restricted to qualitative (subjective) data. Examples are shown in Figure 6.

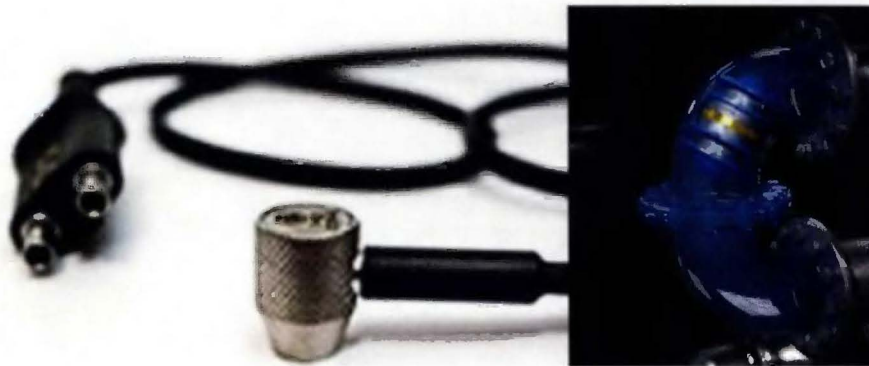
**Figure 7: Typical Ultrasonic Pipe Probes (Probe - Left, Ultrasonic Pipe Pig - Right)**

Ultrasonic detectors use high-energy sound waves to measure wall thicknesses. This is an established method for pipe inspection. Ultrasonic detectors may take discrete measurements (spot) or complete measurement using multiple probes. The ultrasonic probes are quite small but in most cases require good contact with the surface and may not read well through corrosion products. They are ideal for external measurements of pipes with internal corrosion but not as common for internal measurements. Typical ultrasonic detectors are shown in Figure 7.

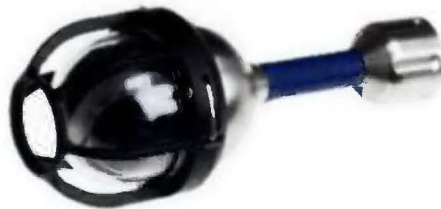
*Figure 9: Example of Pan and Tilt Borescope Camera*

Borescopes come in a variety of sizes, lengths, and abilities (e.g., articulating, pan-and-tilt cameras, flexible, rigid). Figure 9 is an example of a pan-and-tilt borescope camera head. The available port size first considered for this application is restricted to 0.75 inches in diameter to prevent the need for further modification of the duct. Inspecting every foot of the duct is difficult due to the need to inspect duct runs greater than 50 feet long (up to 250 feet in the case of AP-101 and AP-107).

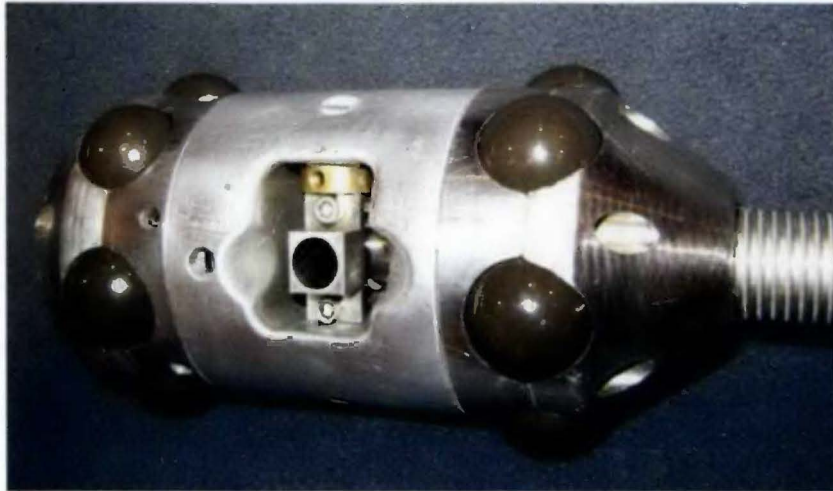
**Figure 10: Example of Push Style Ultrasonic Probe**

Ultrasonic sensors are relatively small and could potentially be deployed through penetrations as small as 0.75 inches but certainly in penetrations below 2 inches. These probes would be mounted on push style probes that would lie on the bottom of the duct. These could be pushed up to and beyond 10 feet although this would have to be determined in testing. Like borescopes, the main factors would be the ability to push a semi-rigid cable. Figure 10 is an example of a typical push style ultrasonic probe.

This simple device could take spot readings on the bottom of the duct only as it would have no actuation or ability to touch any other surfaces. Although this is a very limited area, it is likely that the worst corrosion has occurred at the bottom of the duct as this is where any liquids would lie.

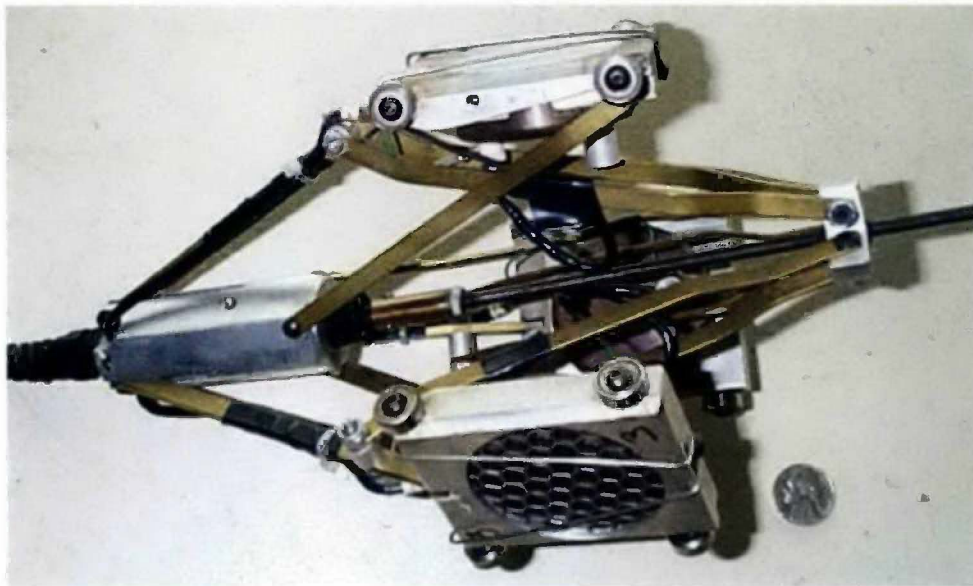
**Figure 11: Example of Expanding Pipe Crawler**

This approach would require an articulated crawler with camera, lights, and drive power. This is a larger device and would require ports at least 6 inches in diameter. Additionally, this device would not be able to pass through butterfly valves. The technology for the UT sensor is mature, but a specialized crawler would have to be developed or adapted from an existing crawler. Although this is less mature, the basic technology for the crawler is well understood. Figure 11 is one example of an expanding pipe crawler.

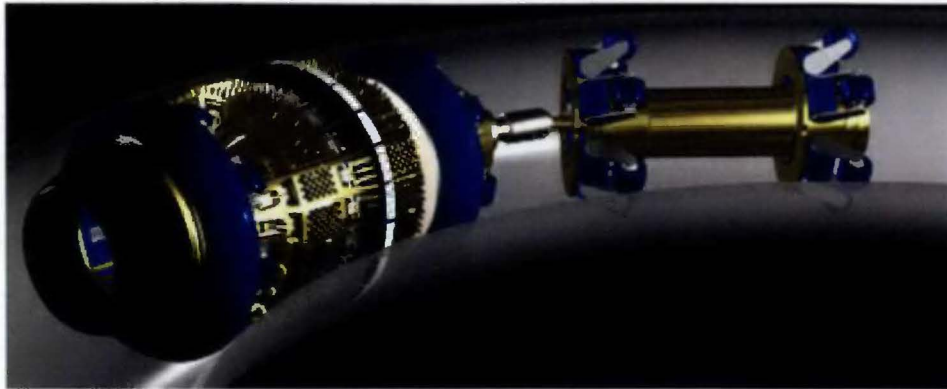
*Figure 13: Magnetic Flux Leakage Device in Pipe Bend*

MFL is a method that creates a magnetic field near the pipe walls and then measures that field. Any change in the wall thickness (corrosion, pitting, holes, etc.) creates anomalies in the field that can be read. This technology would allow every surface of the pipe to be inspected with high confidence. However, these devices are large and must be the same diameter as the pipe. To install one would require a very large penetration into the ductwork. Any obstructions (butterfly valves) would not be tolerated. There are commercial systems available that can maneuver around bends (See Figure 13). However, testing will need to be performed to prove the MFL device(s) could maneuver around the DST duct bends.

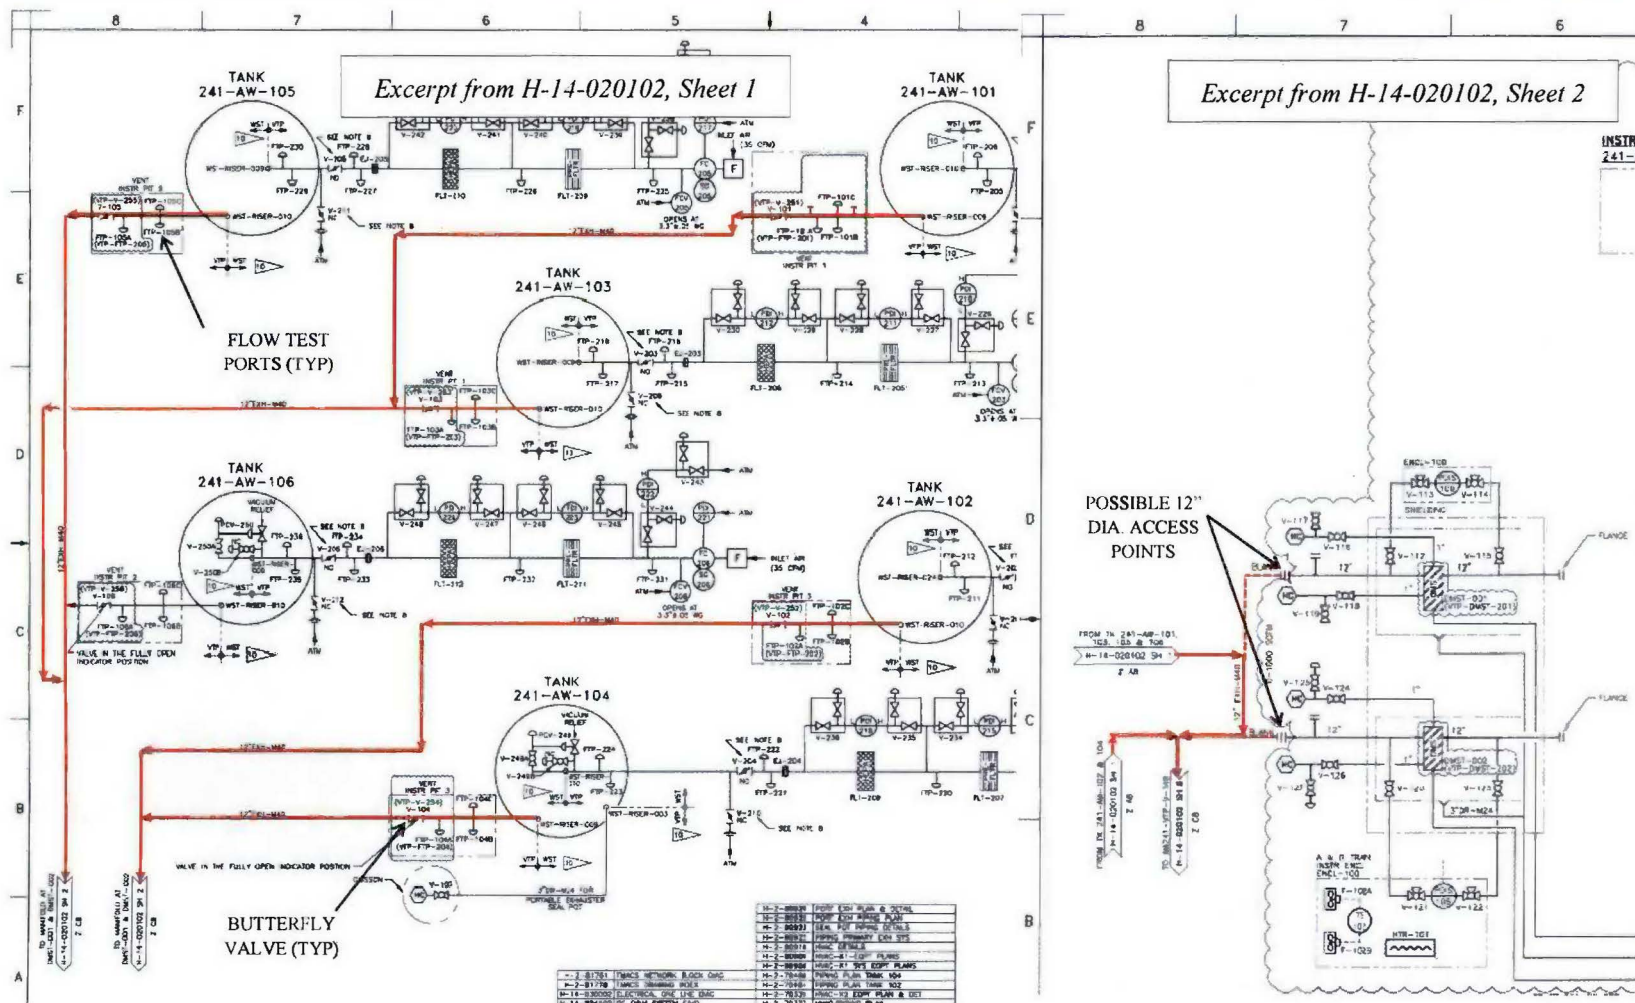
Figure B-2: AW Farm Primary Ventilation P&ID (H-14-020102, Sh. 1 & 2) with Annotations in Red
